What Killed the First MiniBooNE Horn?

L. Bartoszek

Presentation for NBI2005

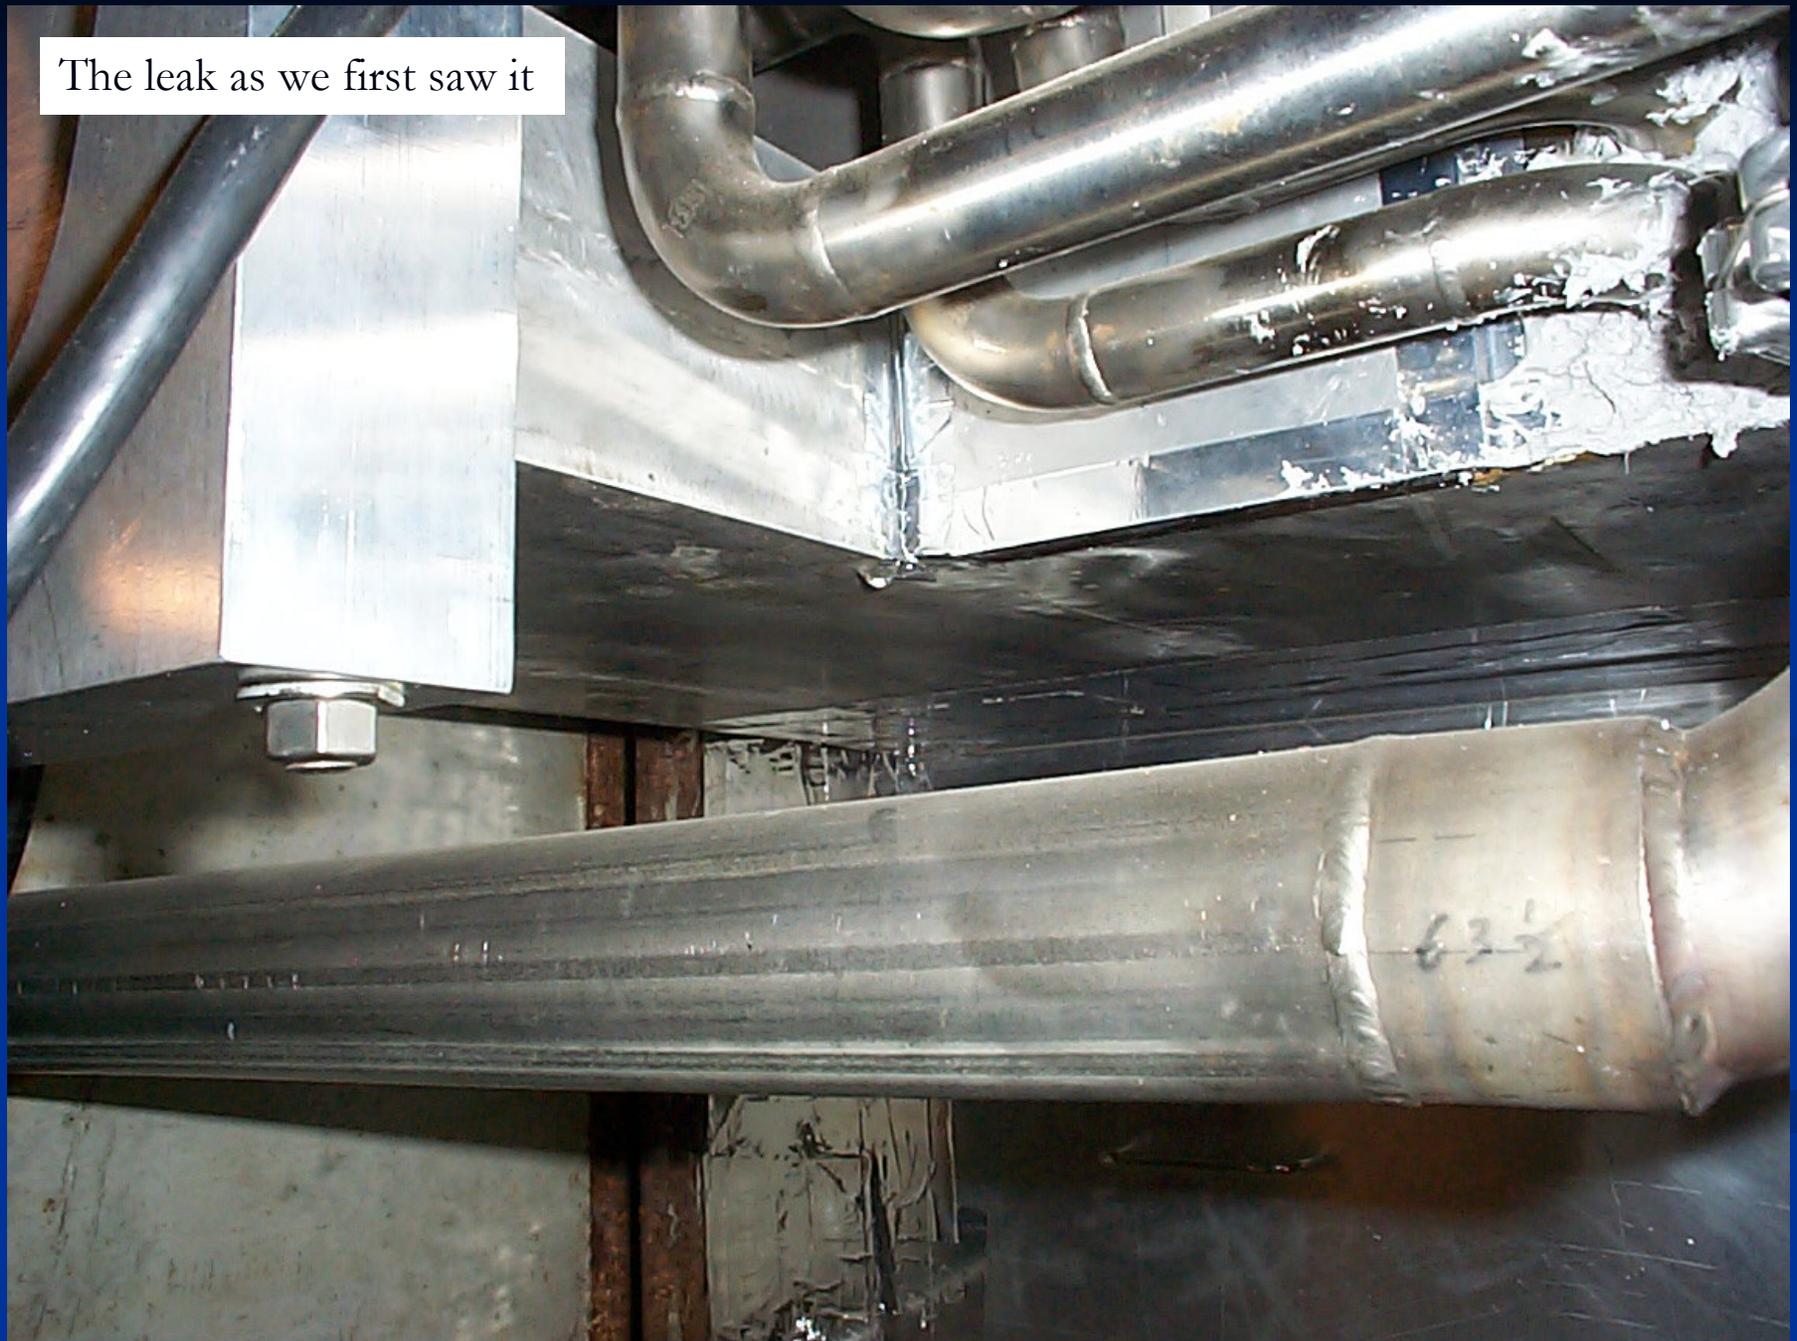
The leak as we first saw it

When we popped the cover plate off several cups of water came out of the 4 x 6 tube

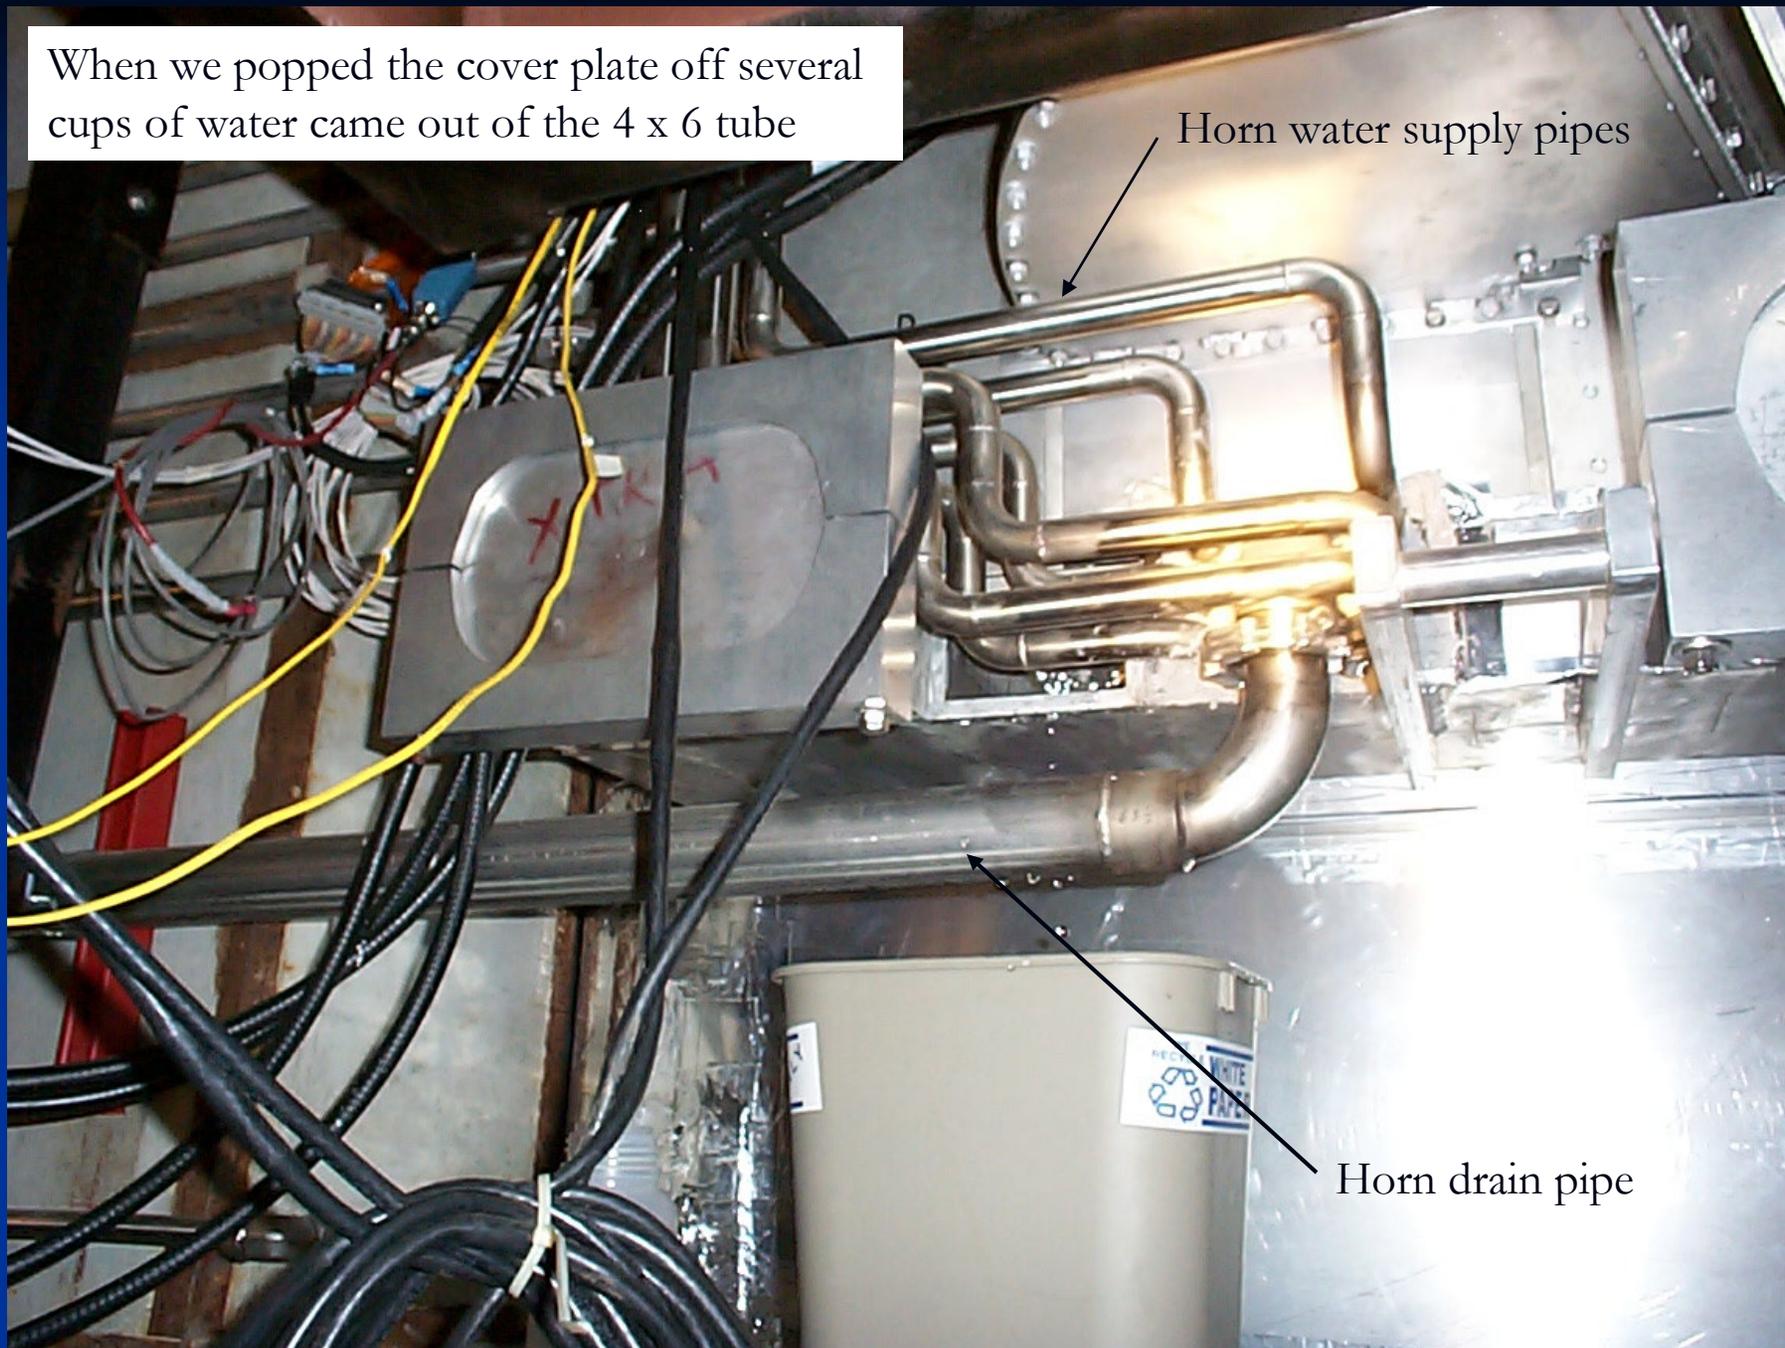
Horn water supply pipes

Horn drain pipe

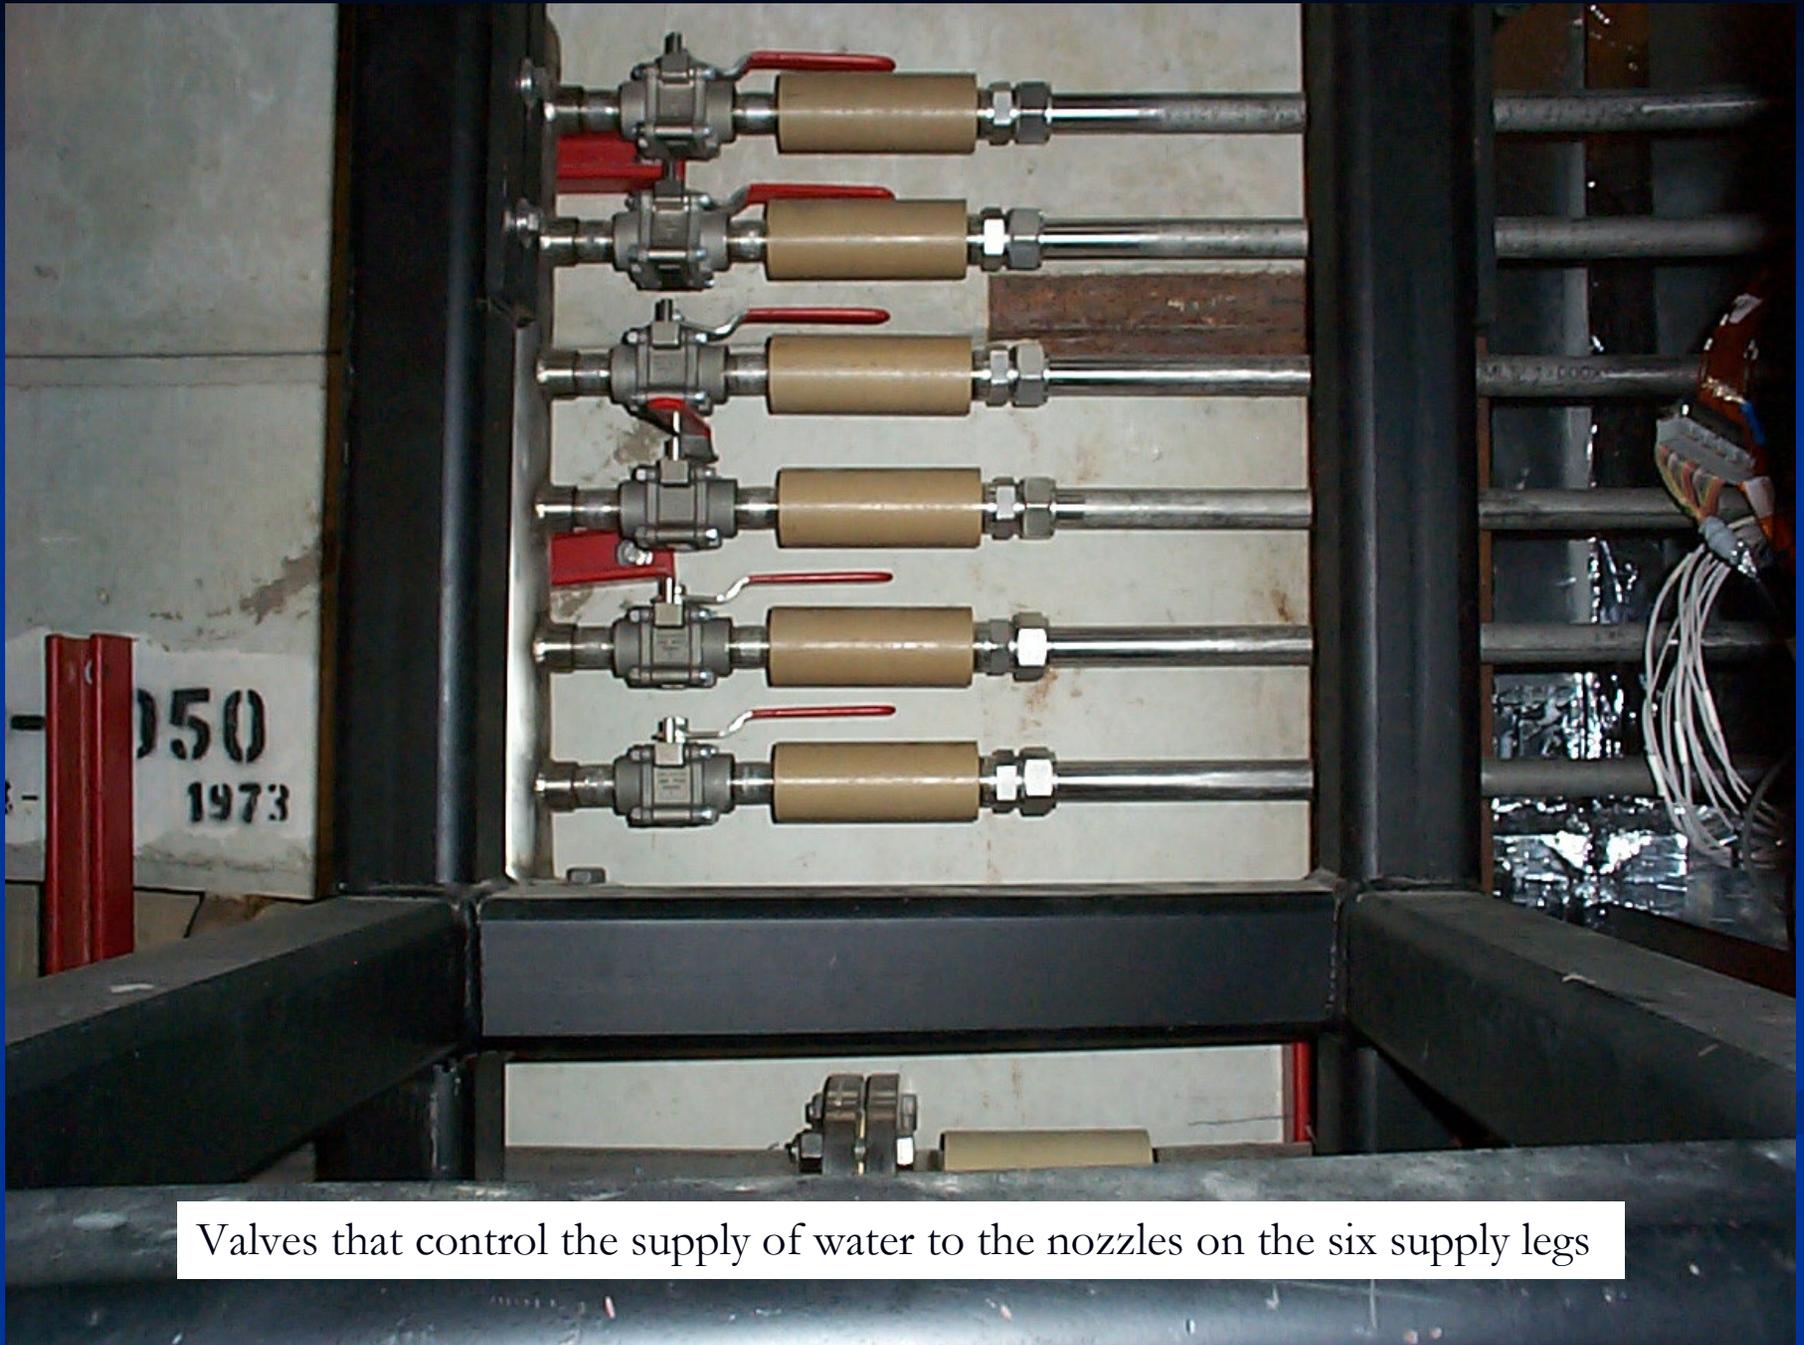
- We turned off the supply legs one by one to see if the leak would stop
- The leak rate did not change when any of the legs on the left (same side as the leak) were turned off—stayed 35 mL/hr
- The leak rate dropped to 1/3 of the original when any of the right legs were turned off
- The leak only went away when the entire system was shut off

Valves that control the supply of water to the nozzles on the six supply legs

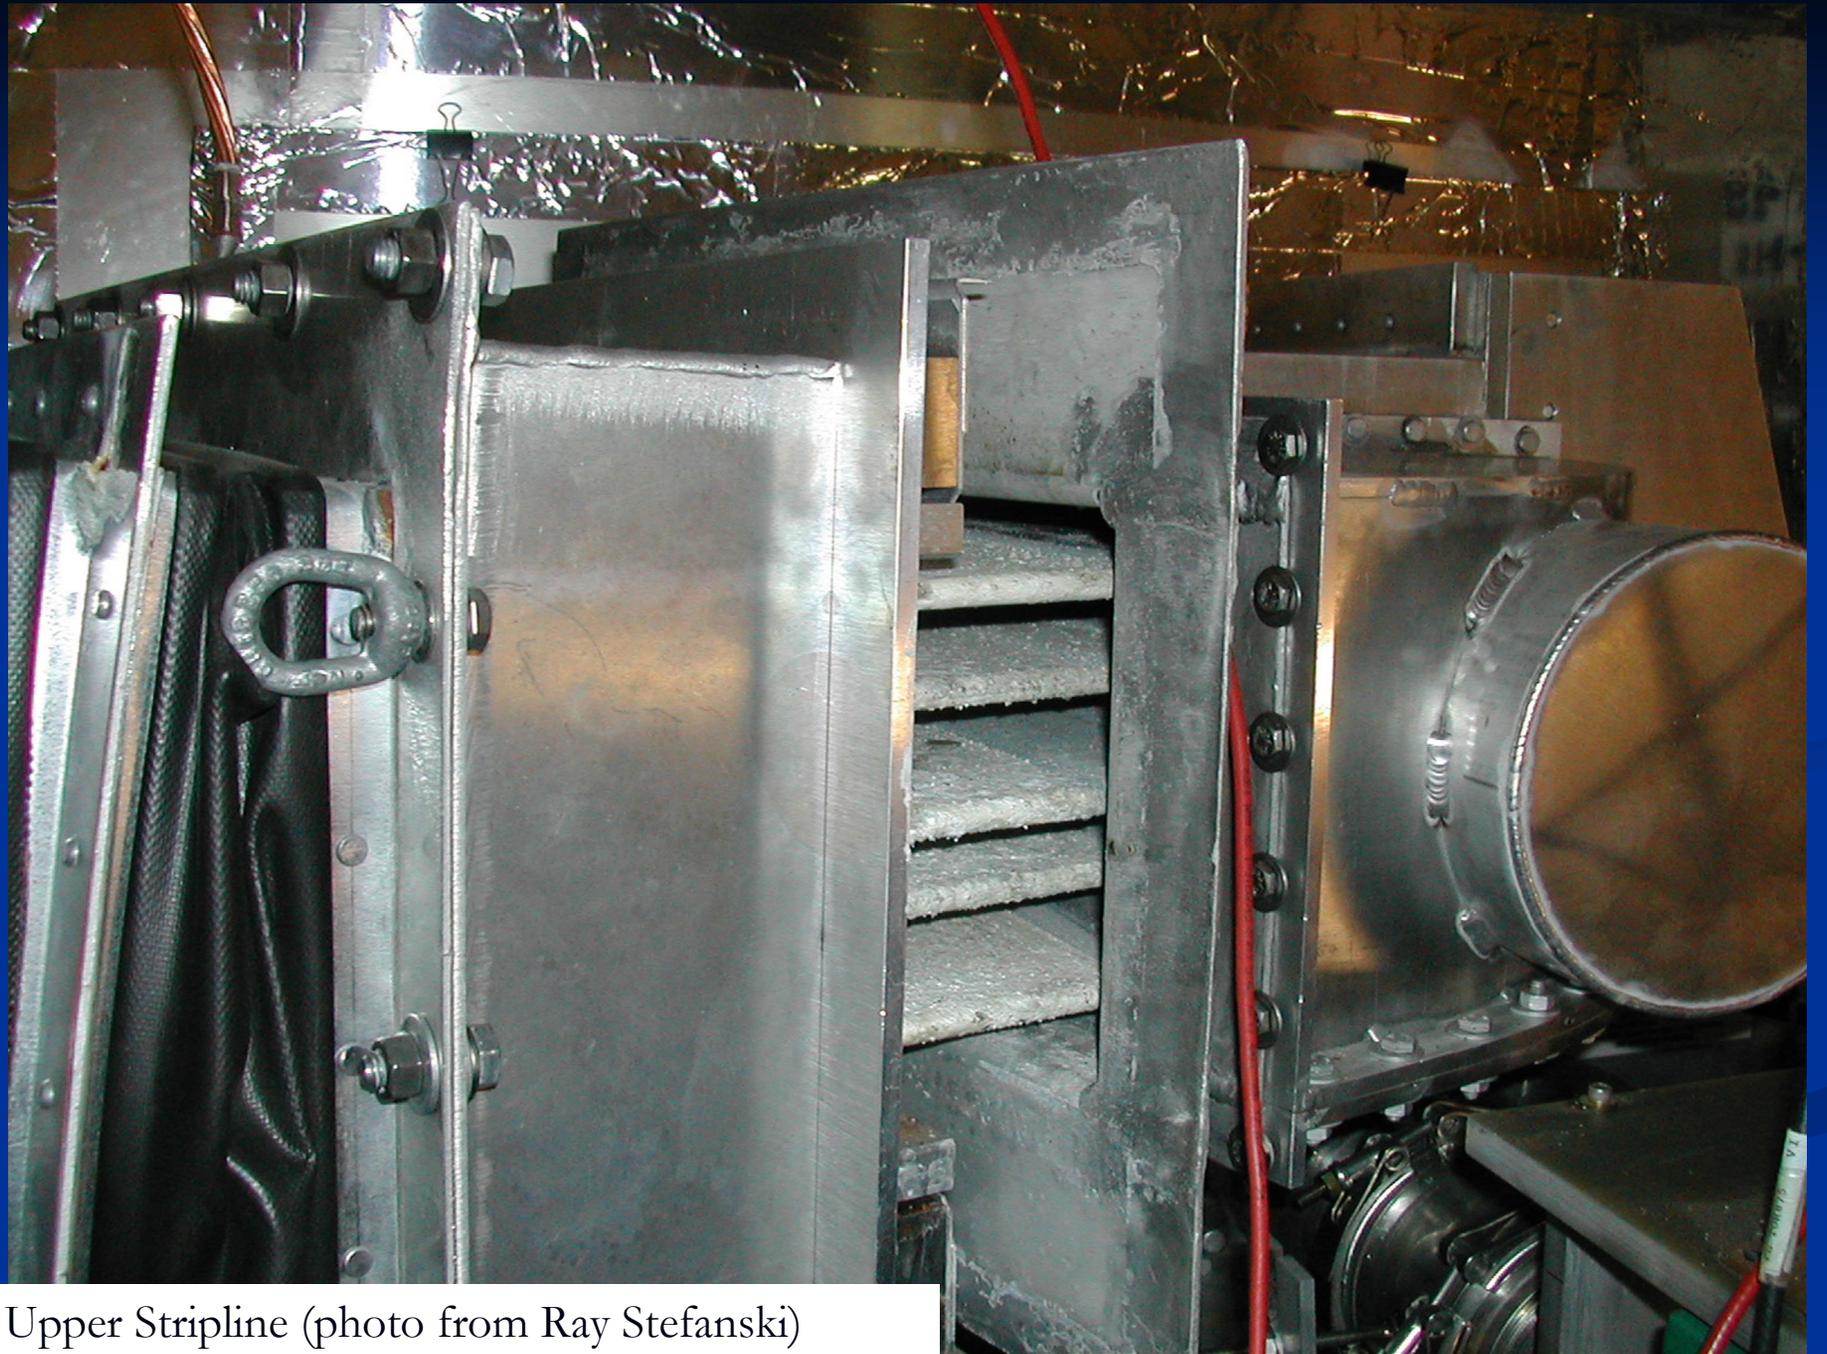
- The next few pictures show where we saw stripline corrosion—and where we didn't
- The corrosion ended right at the air barrier on the stripline
- The parts inside the horn box are covered with a white powder that is mostly aluminum oxide and makes the pictures look like those from sunken ships

Upper Stripline (photo from Ray Stefanski)

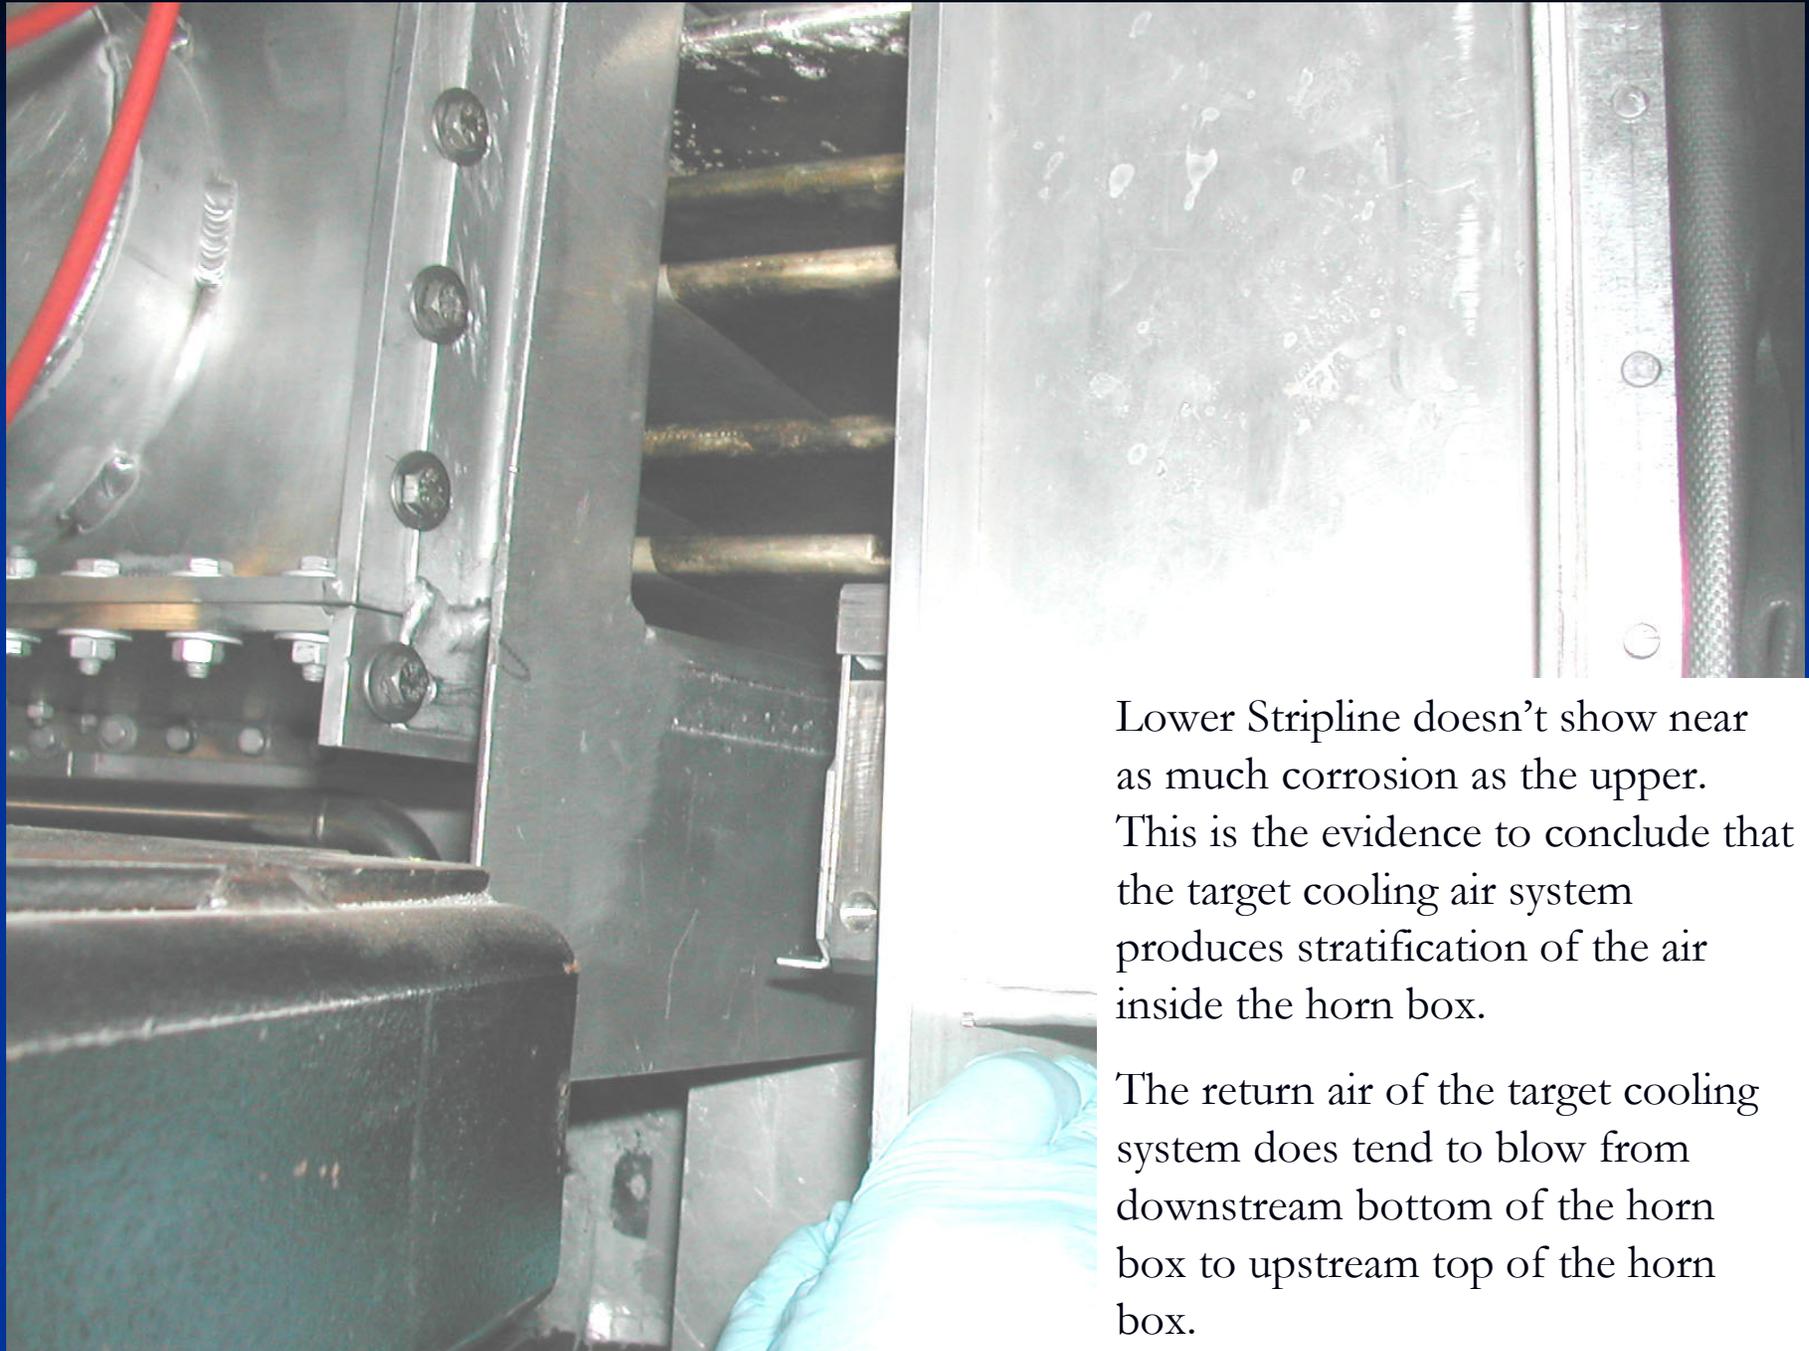
Lower Stripline doesn't show near as much corrosion as the upper. This is the evidence to conclude that the target cooling air system produces stratification of the air inside the horn box.

The return air of the target cooling system does tend to blow from downstream bottom of the horn box to upstream top of the horn box.

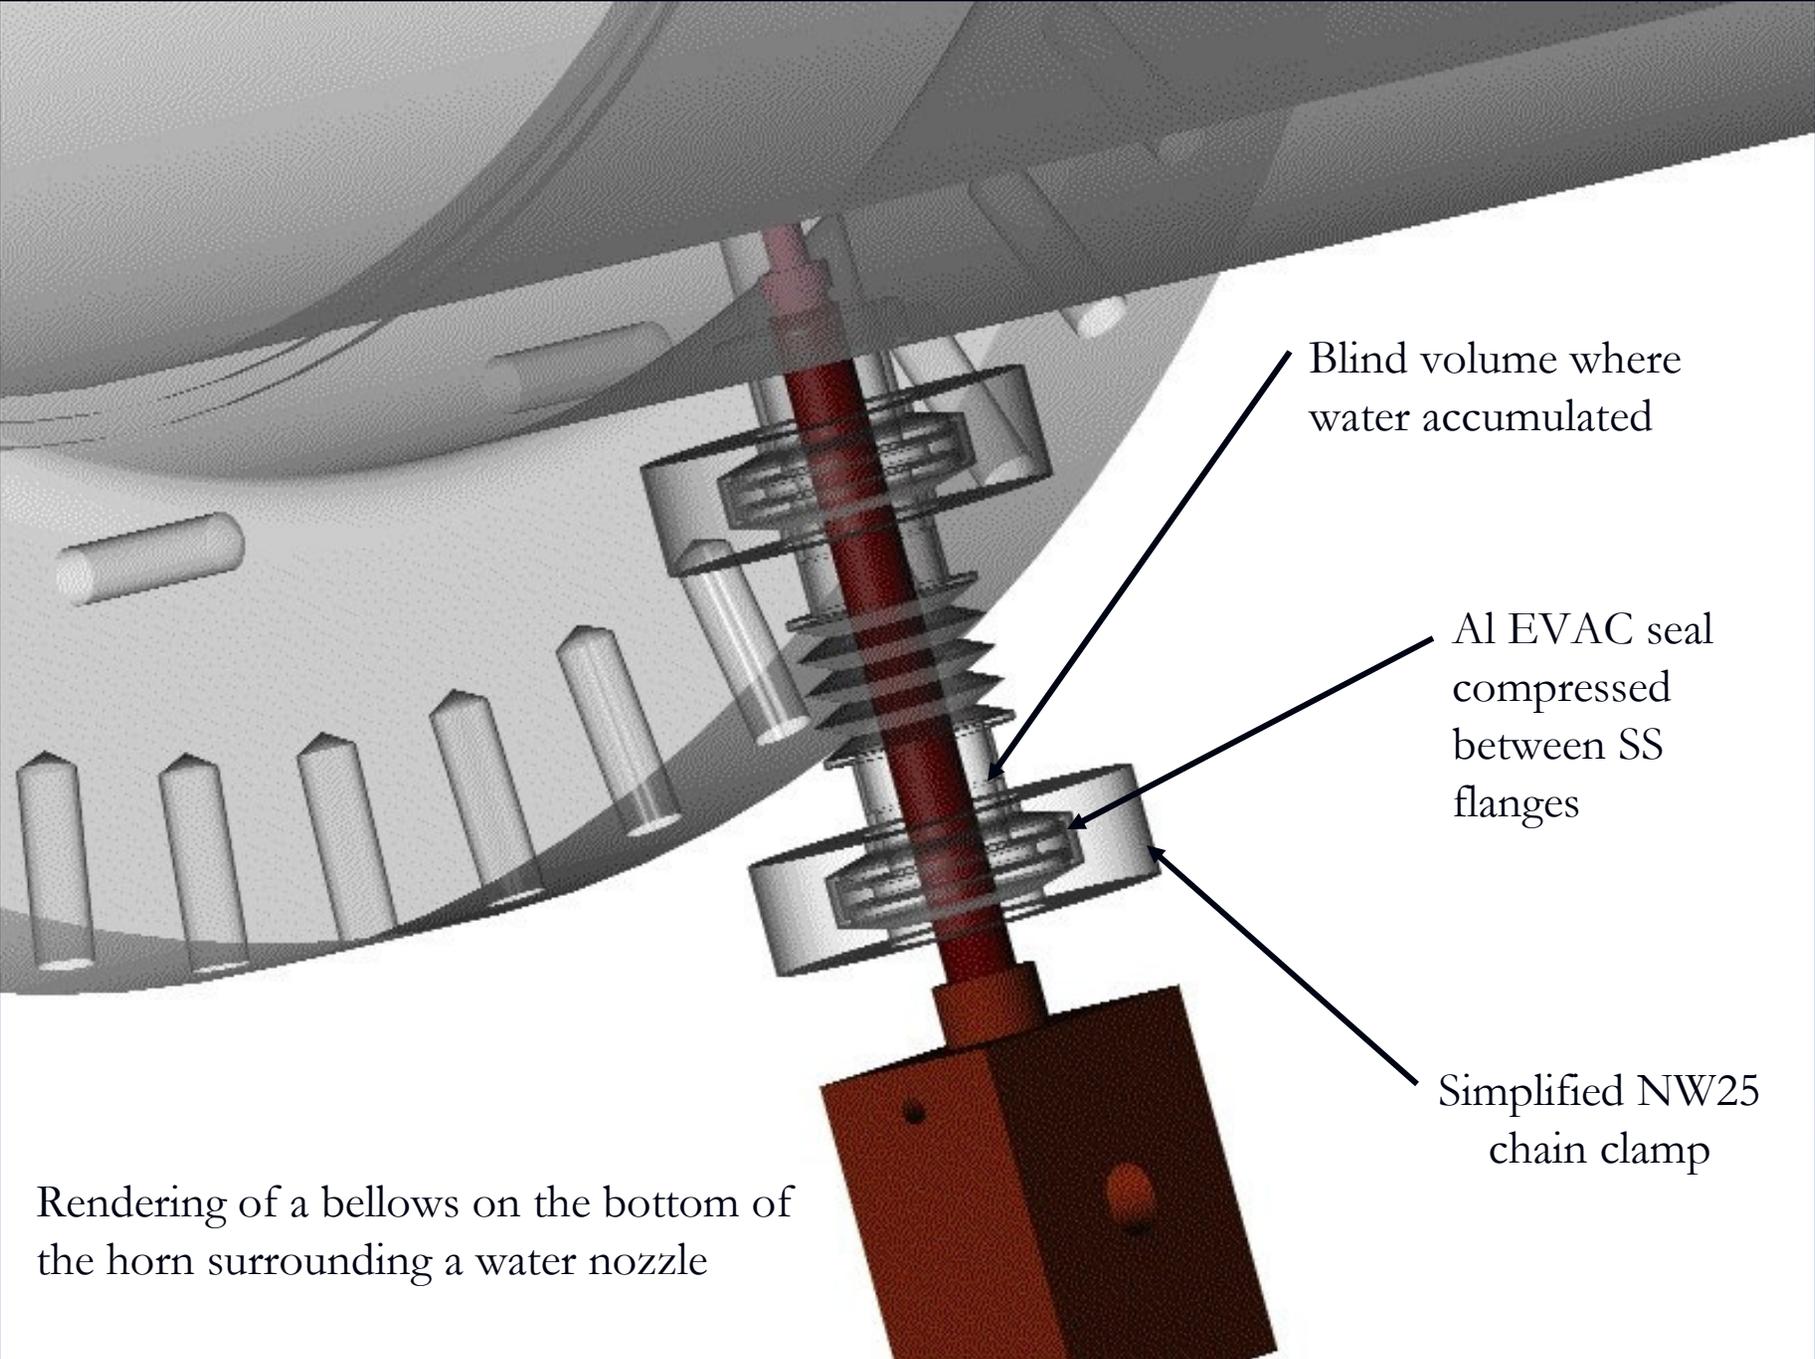
- We finally opened up the horn box and looked at the horn in January, 2007
- My guess of galvanic corrosion of an aluminum seal between two stainless flanges on a bellows on the bottom left side of the horn was confirmed.
- The bellows on the bottom of the first horn trapped water that never got exchanged and cleaned
 - Radiation induced chemistry accumulated in these
 - Aluminum acts as a sacrificial anode for stainless

Blind volume where
water accumulated

Al EVAC seal
compressed
between SS
flanges

Rendering of a bellows on the bottom of
the horn surrounding a water nozzle

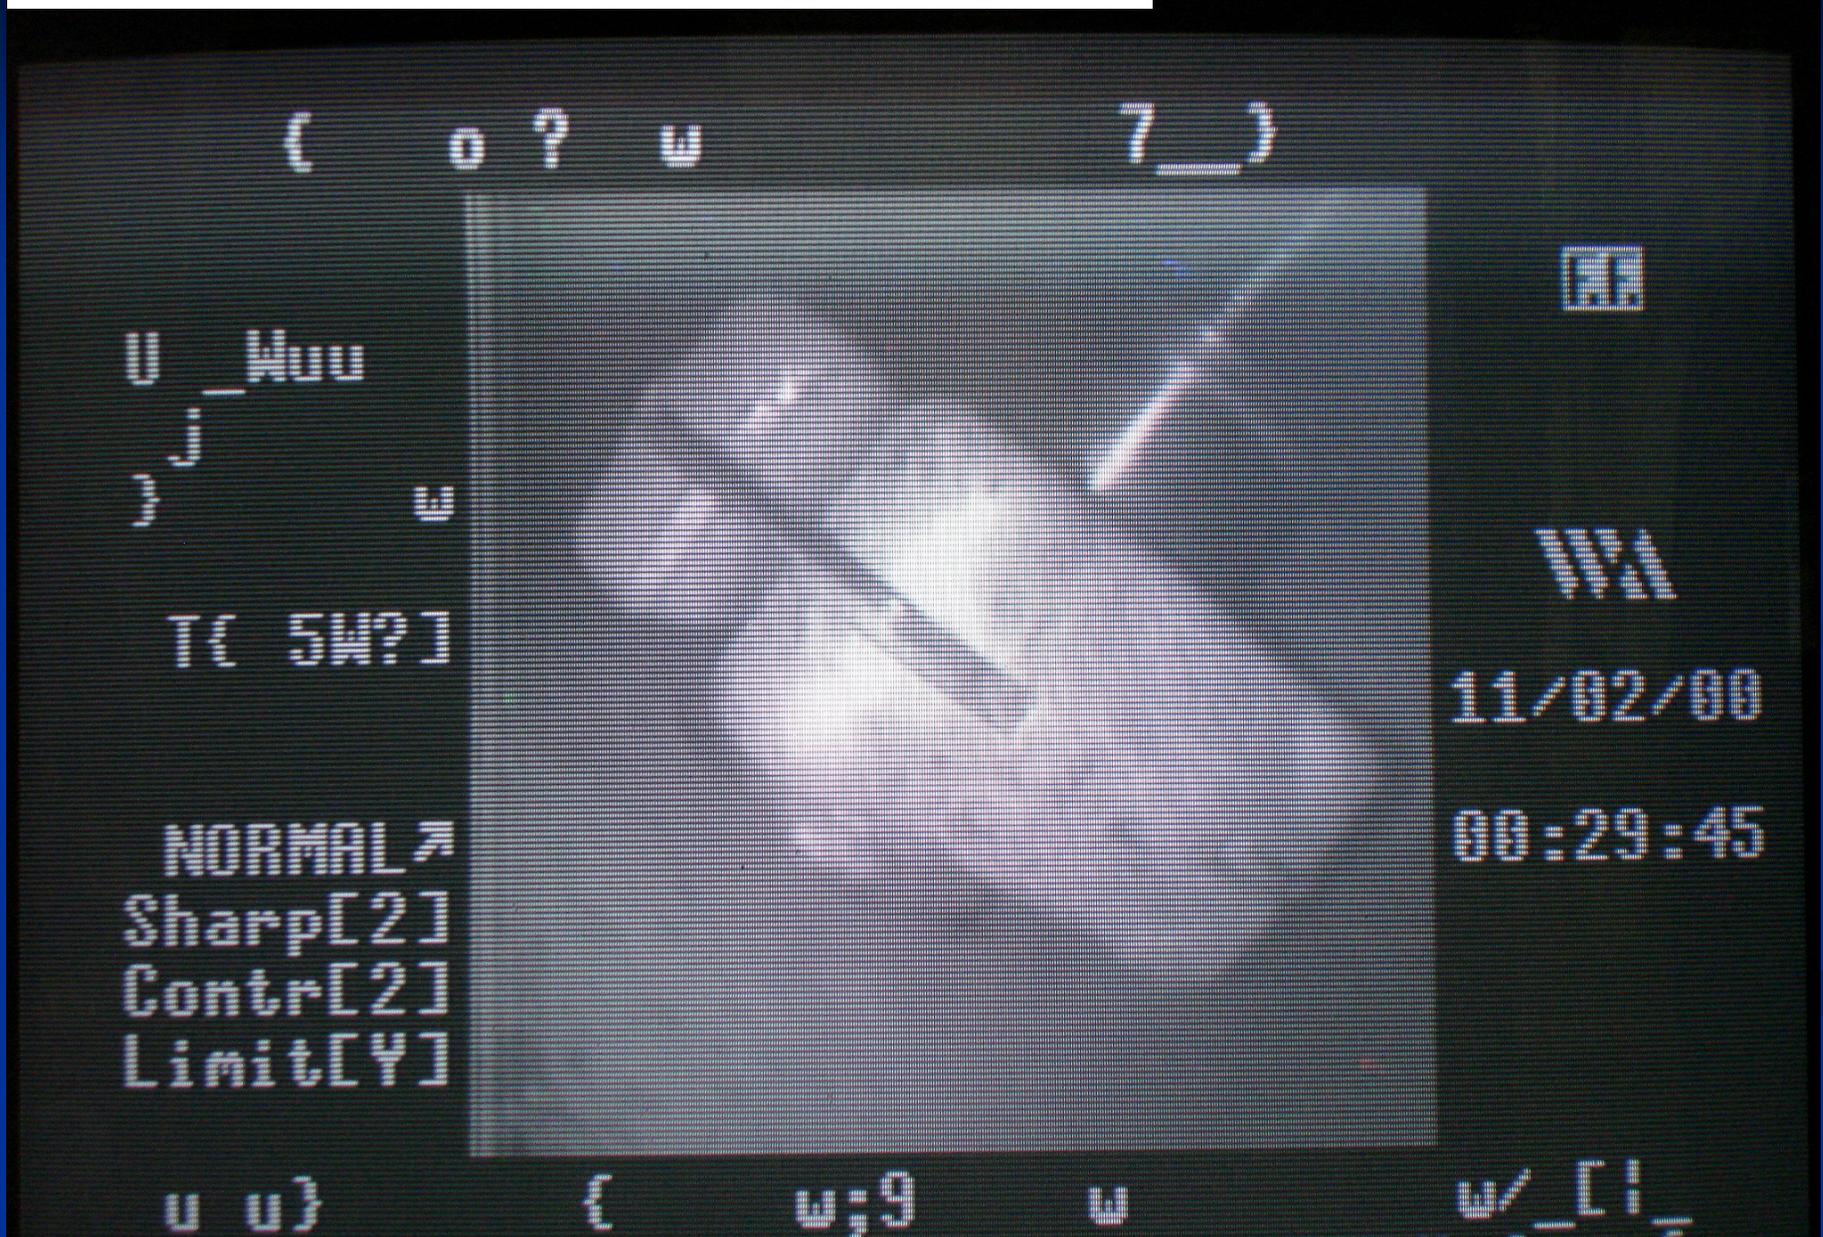
Borescope photo of an EVAC chain clamp around a lower right water nozzle port. No sign of leakage and corrosion.

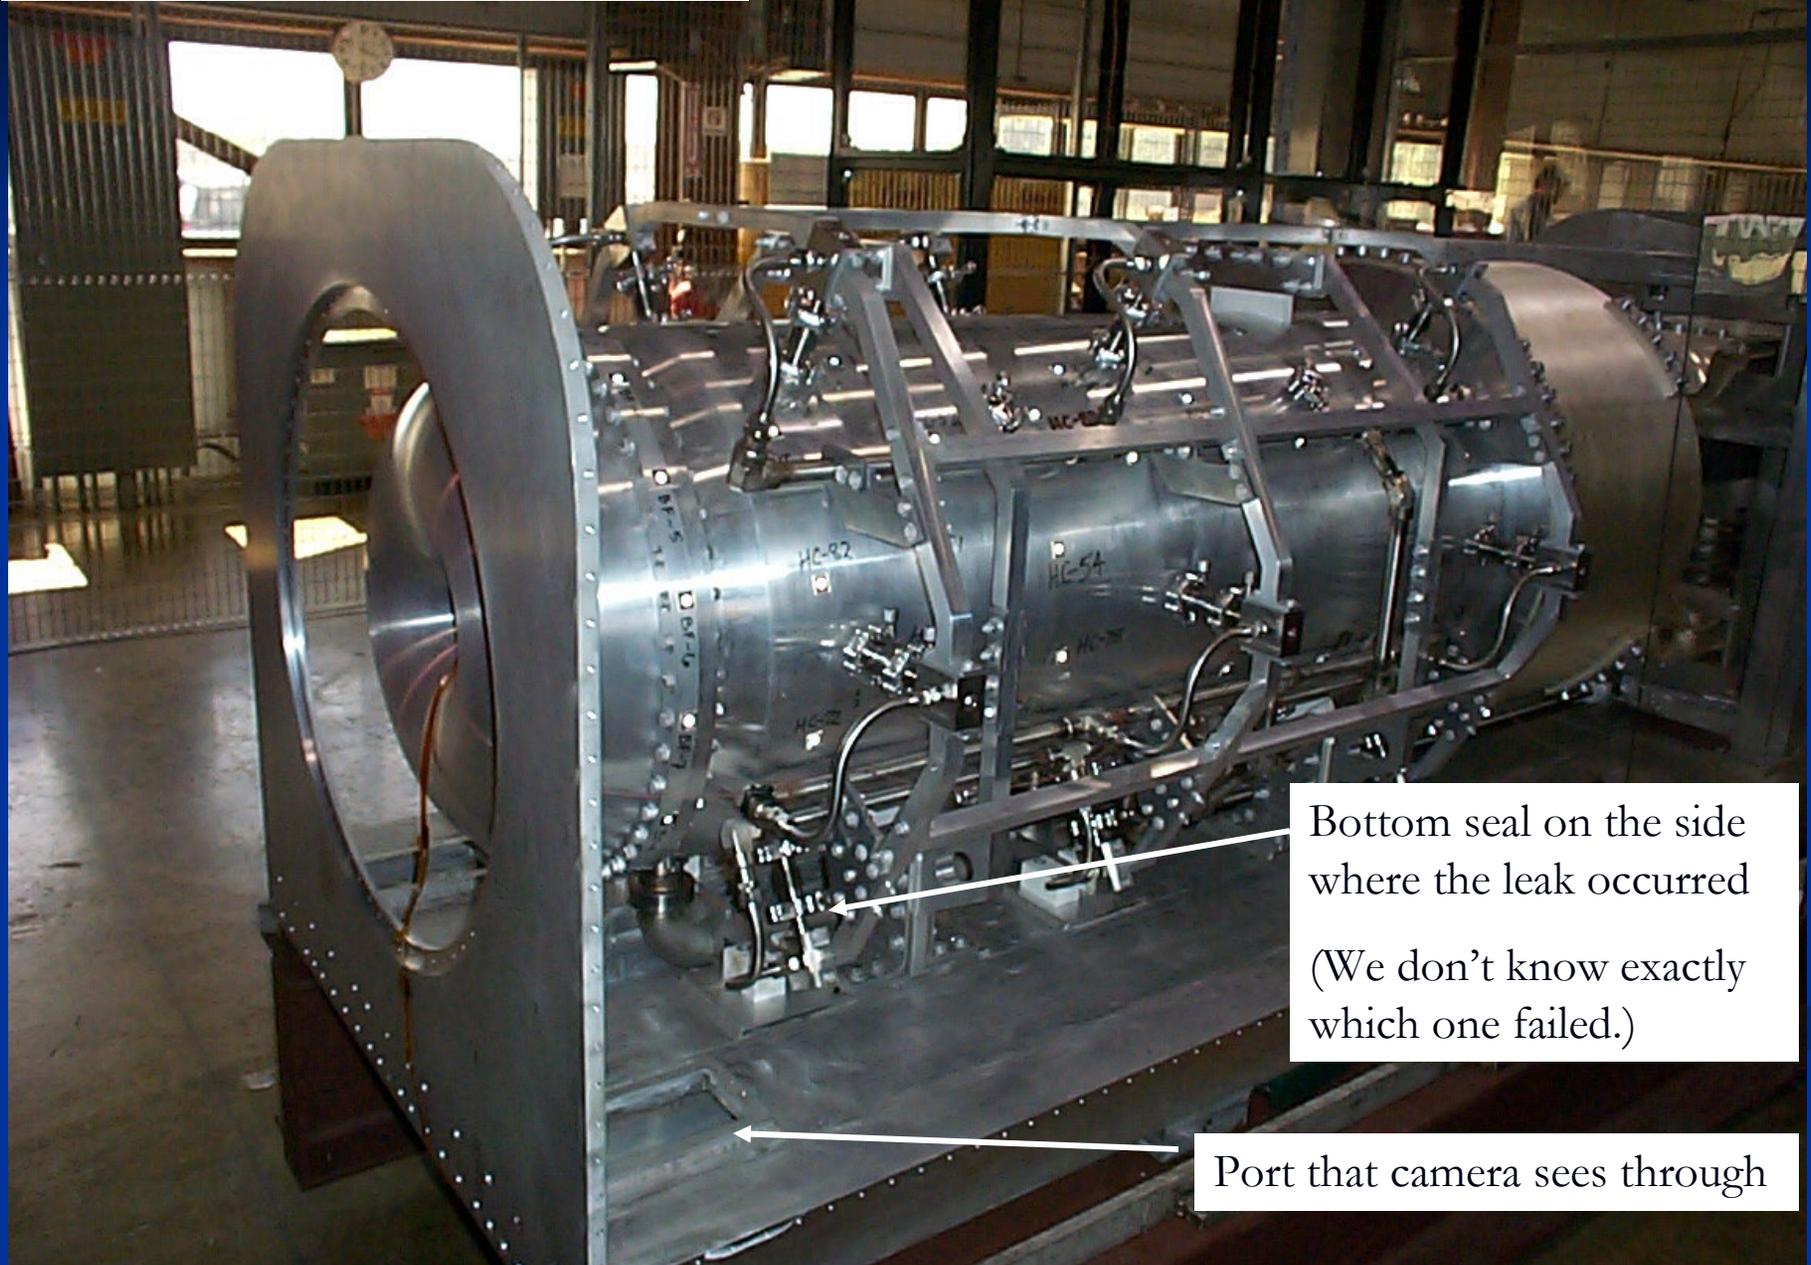
Water truss and bellows around horn

Bottom seal on the side where the leak occurred
(We don't know exactly which one failed.)

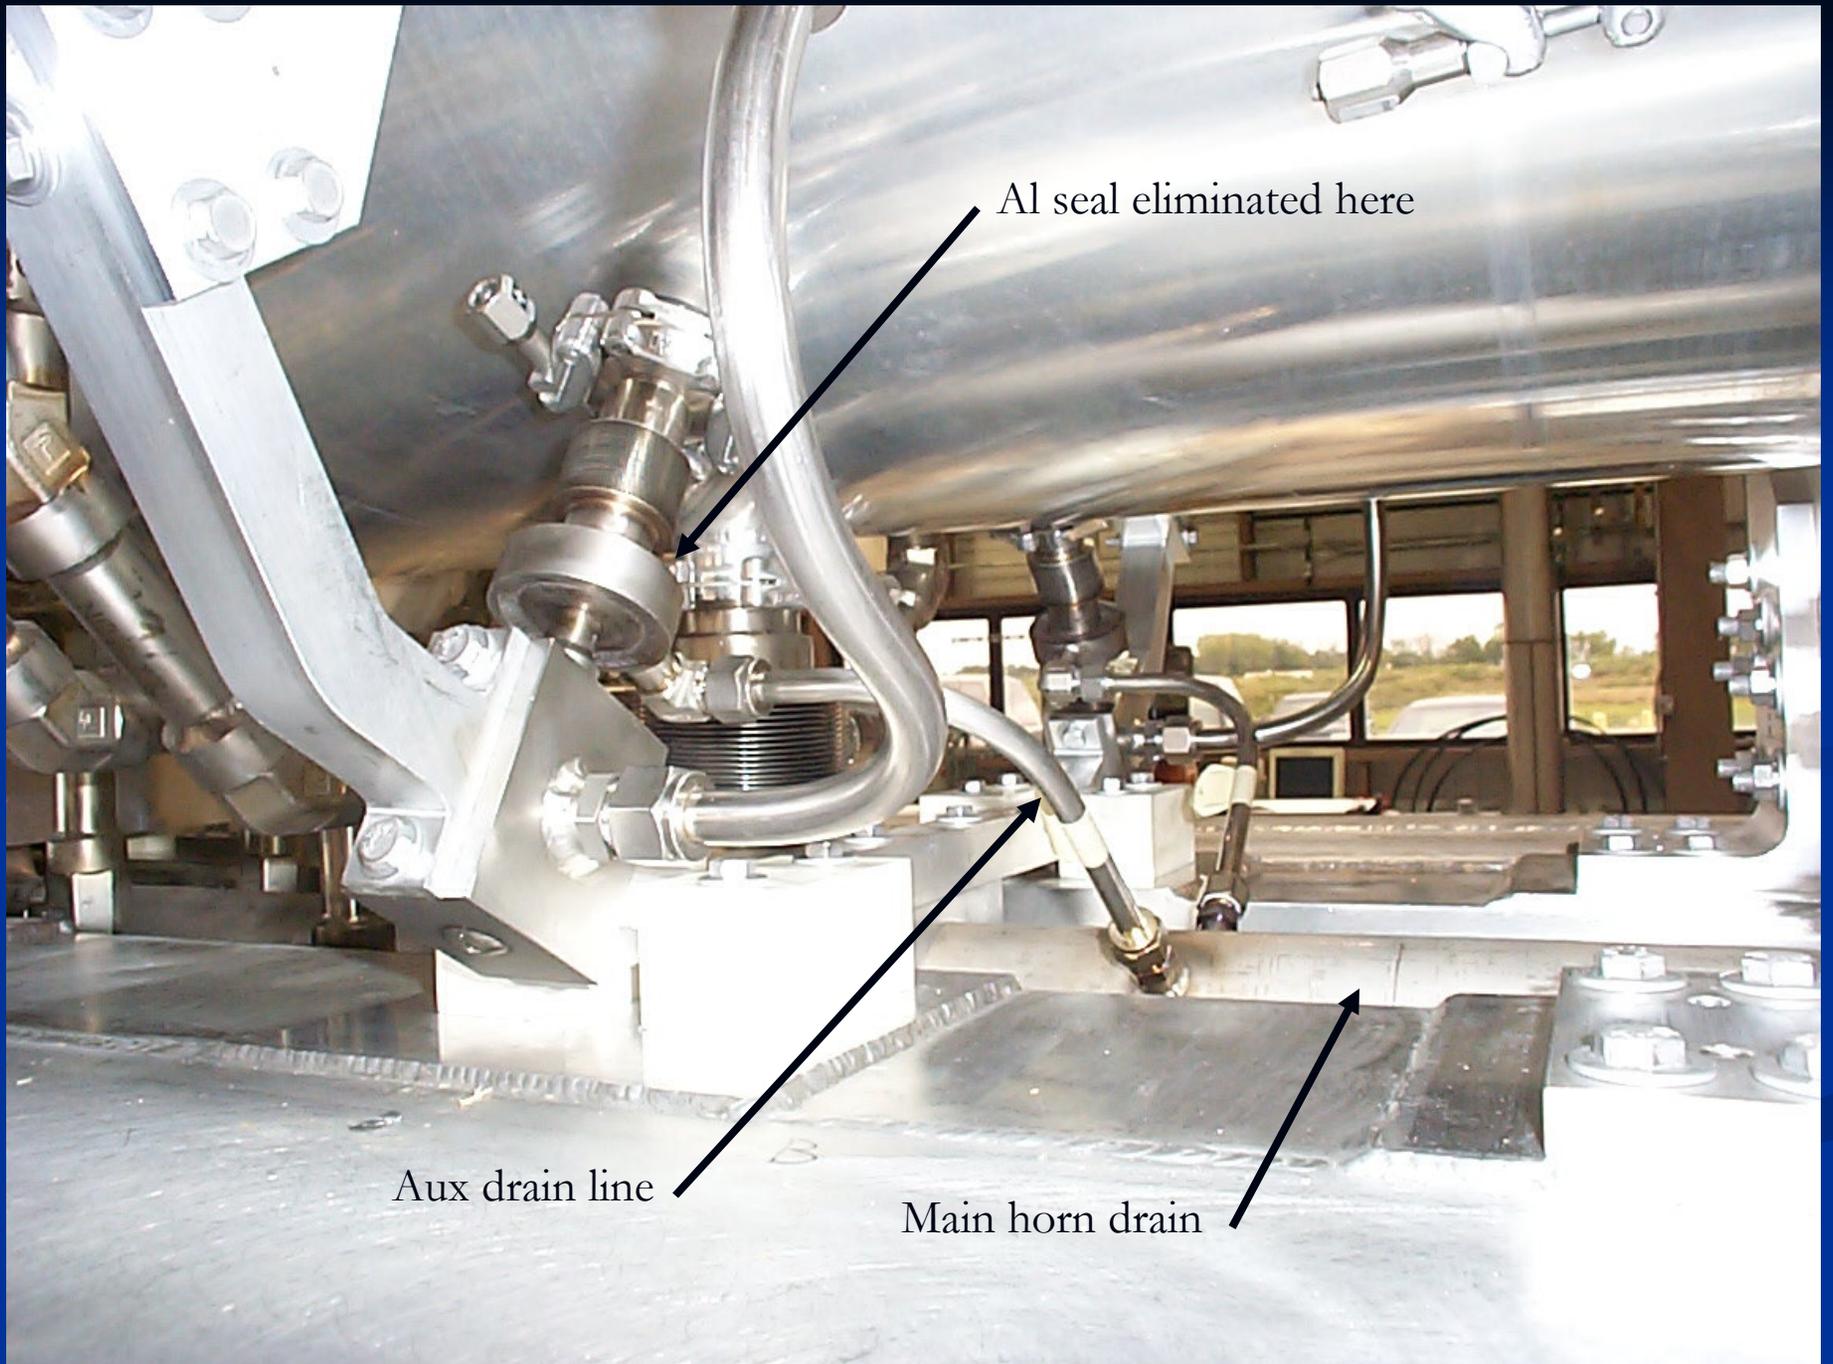
Al seal eliminated here

Aux drain line

Main horn drain

- We welded the flanges on the bottom six bellows eliminating one aluminum seal
- We added an auxiliary drain to prevent water from collecting in the bottom six bellows
- The leak collection tank became a permanent part of the RAW system
- We improved the ability of the spare horn platform to route water to the leak tank
- We added a new dehumidification system to the horn box
