What Killed the First MiniBooNE Horn?

L. Bartoszek

Presentation for NBI2005

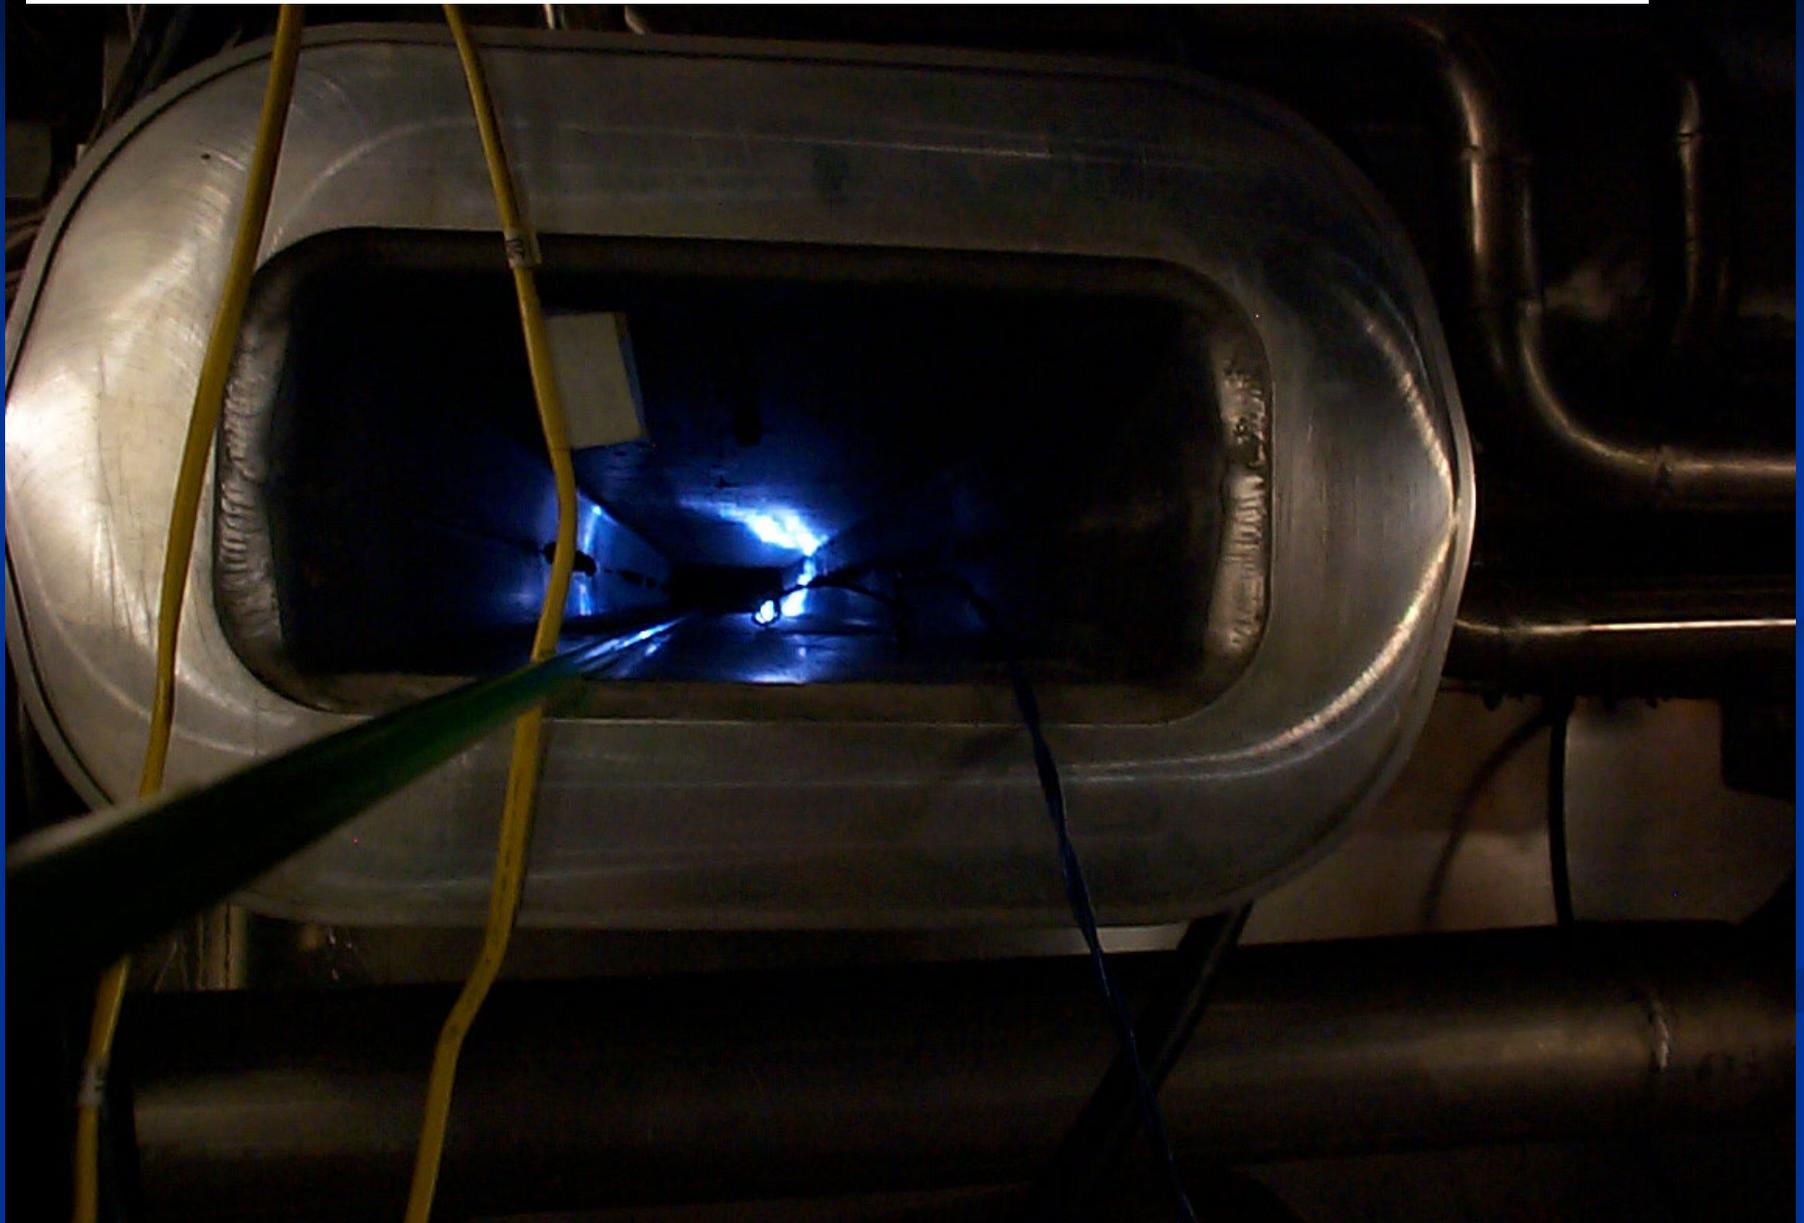
The camera on a stick that could see into the horn box through a hole in the support platform. The hole it looks through is the mirror of the target air return port.

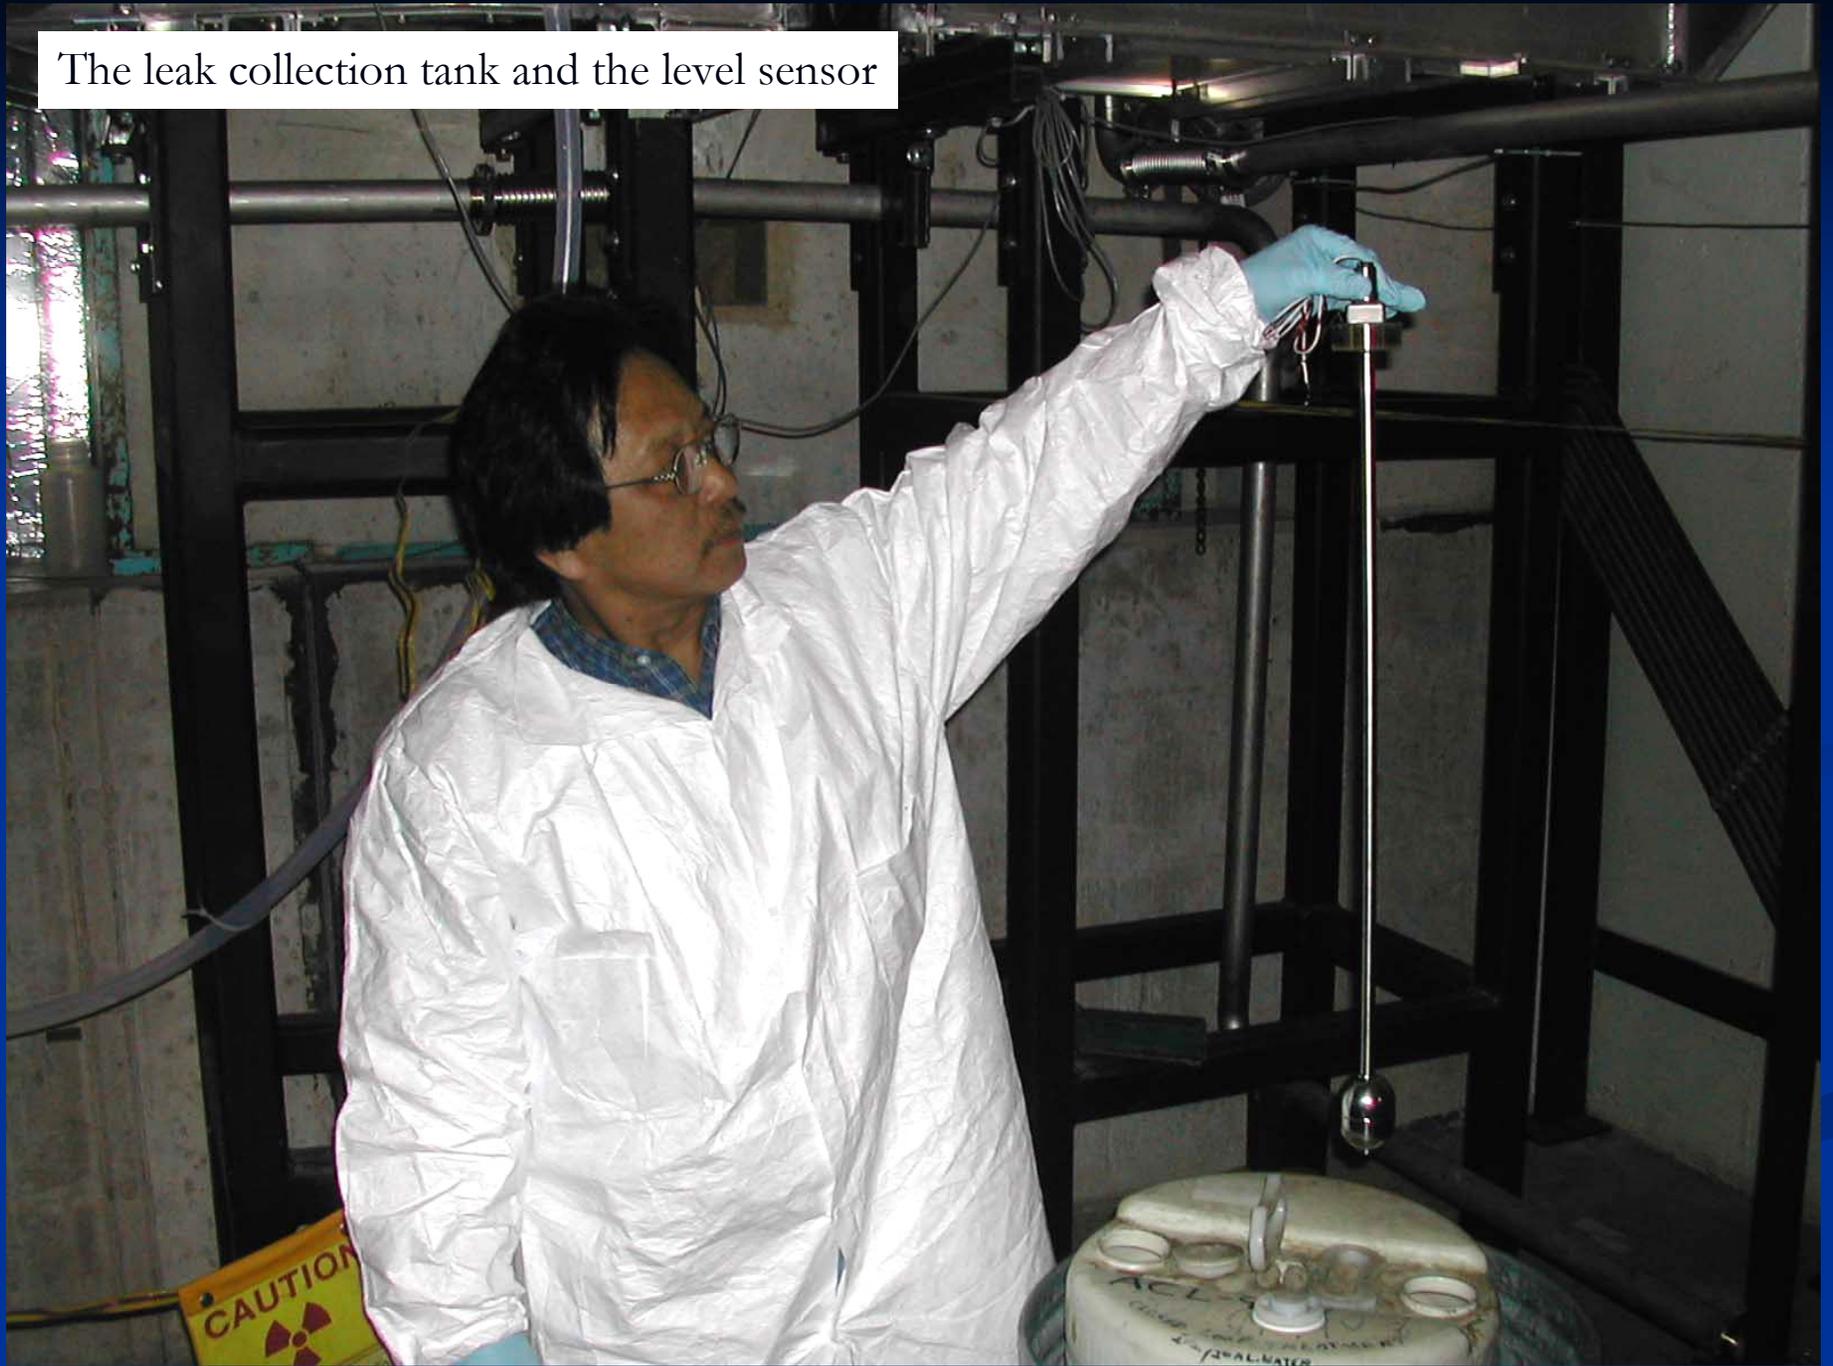
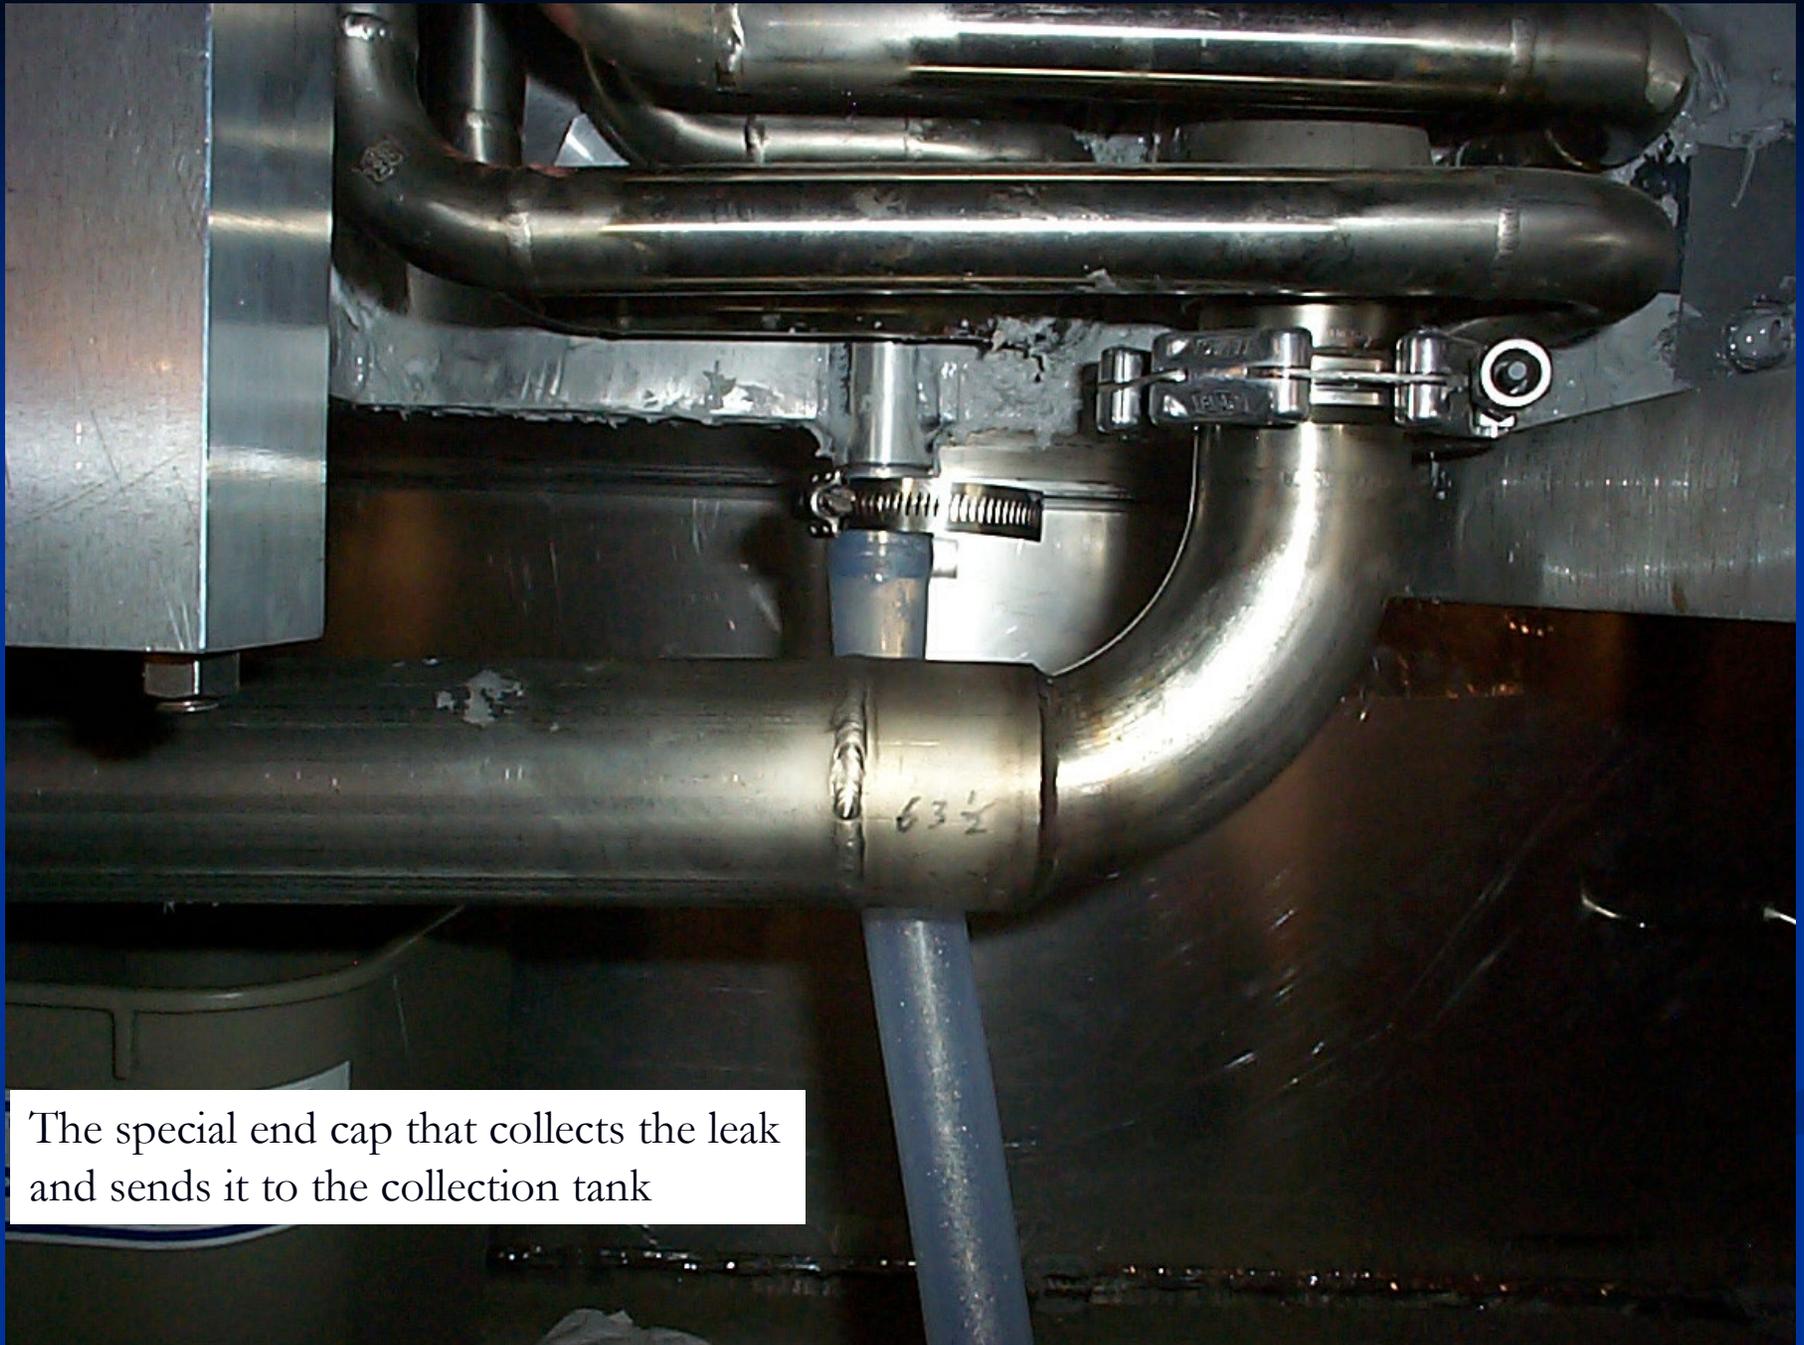
The leak collection tank and the level sensor

The special end cap that collects the leak and sends it to the collection tank

- We added a leak collection system with a liquid level sensor to monitor the amount leaking out
- We added a 5 gallon calibrated bucket to the top of the RAW system surge tank
 - The only measurement of water added to the tank before was an uncalibrated non-linear sight glass
 - Now there is an electronic readout sight glass for continuous monitoring of the level in the surge tank

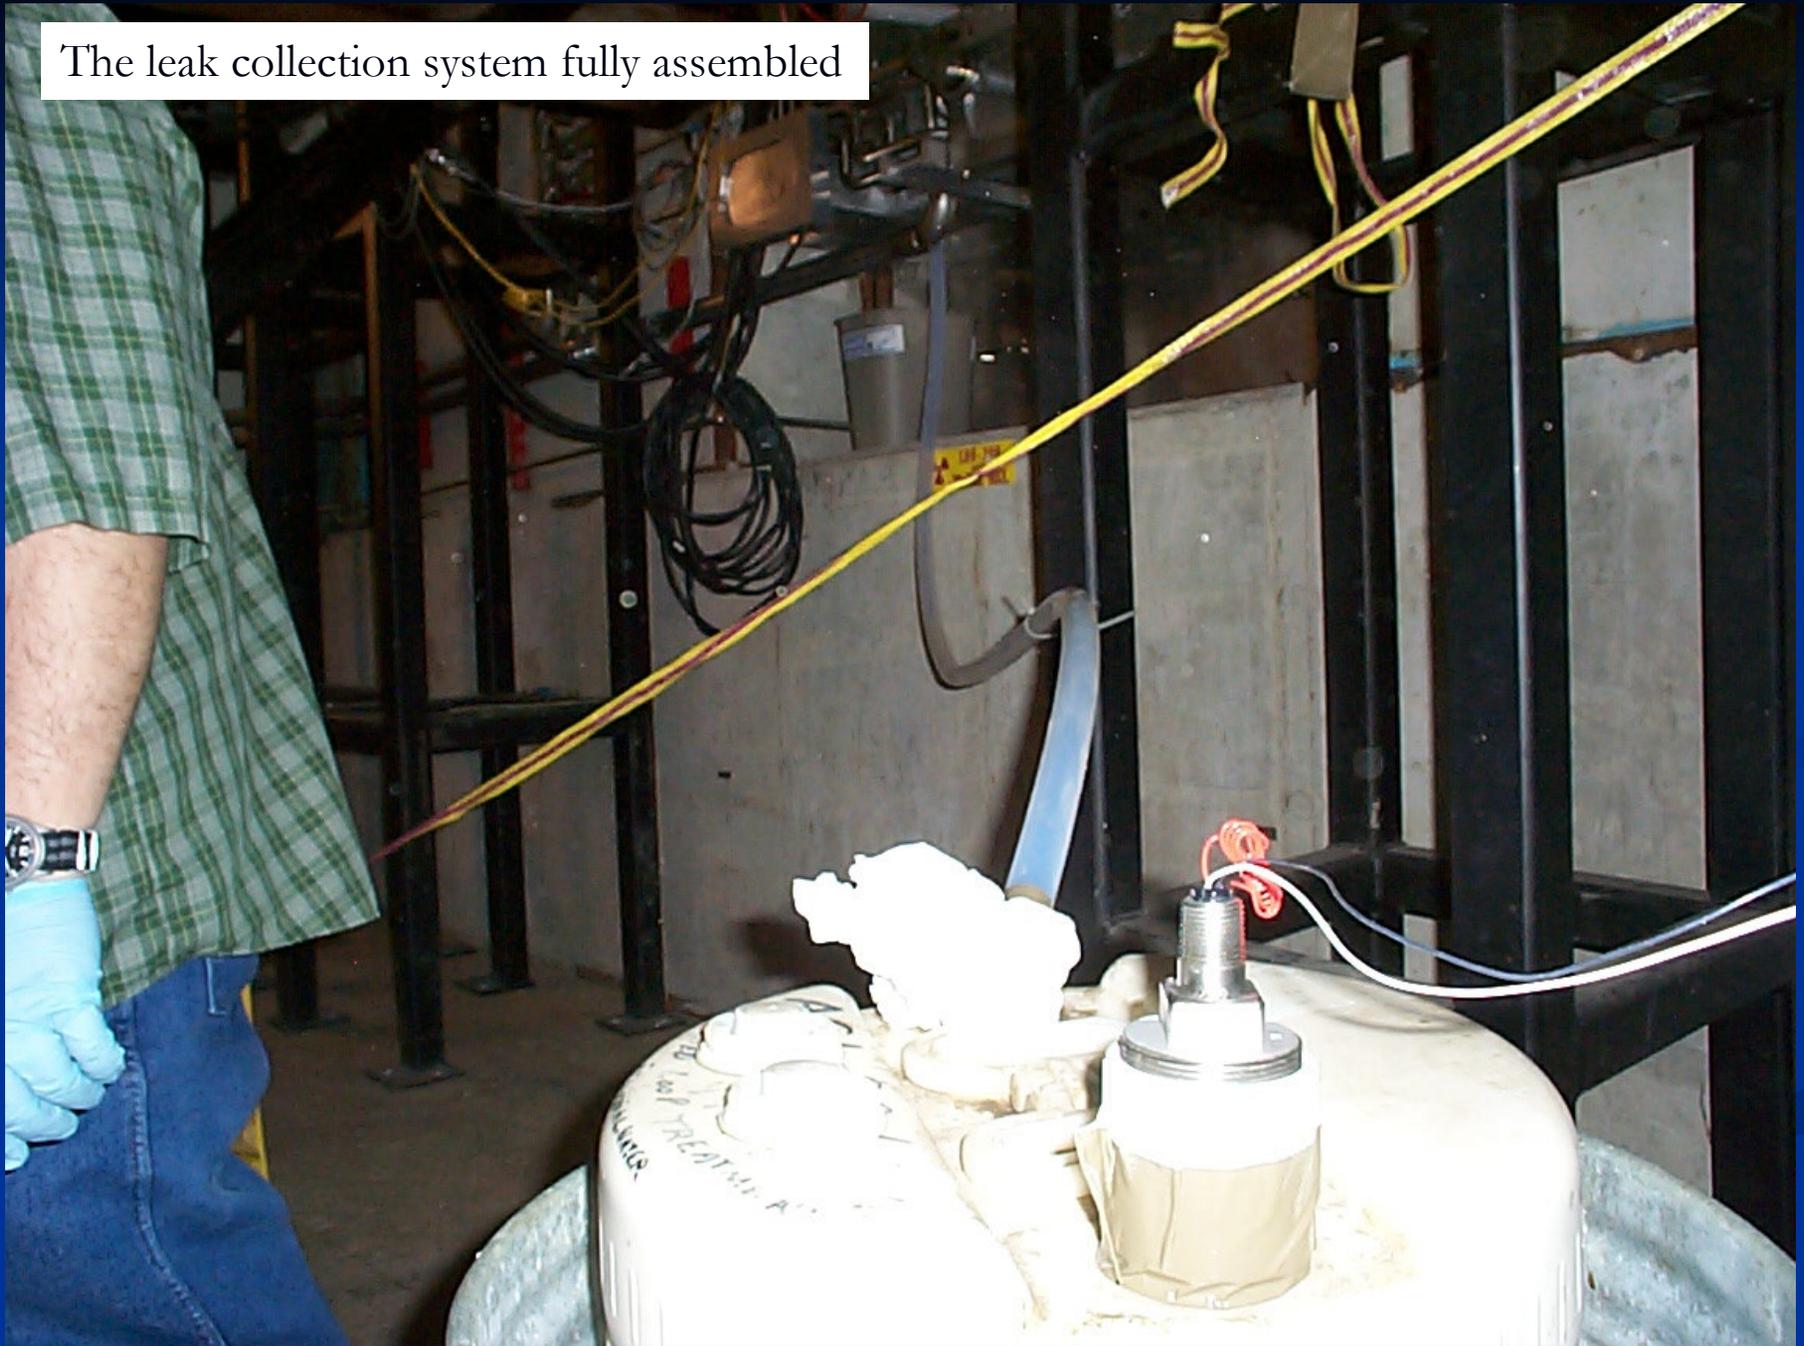
The leak collection system fully assembled

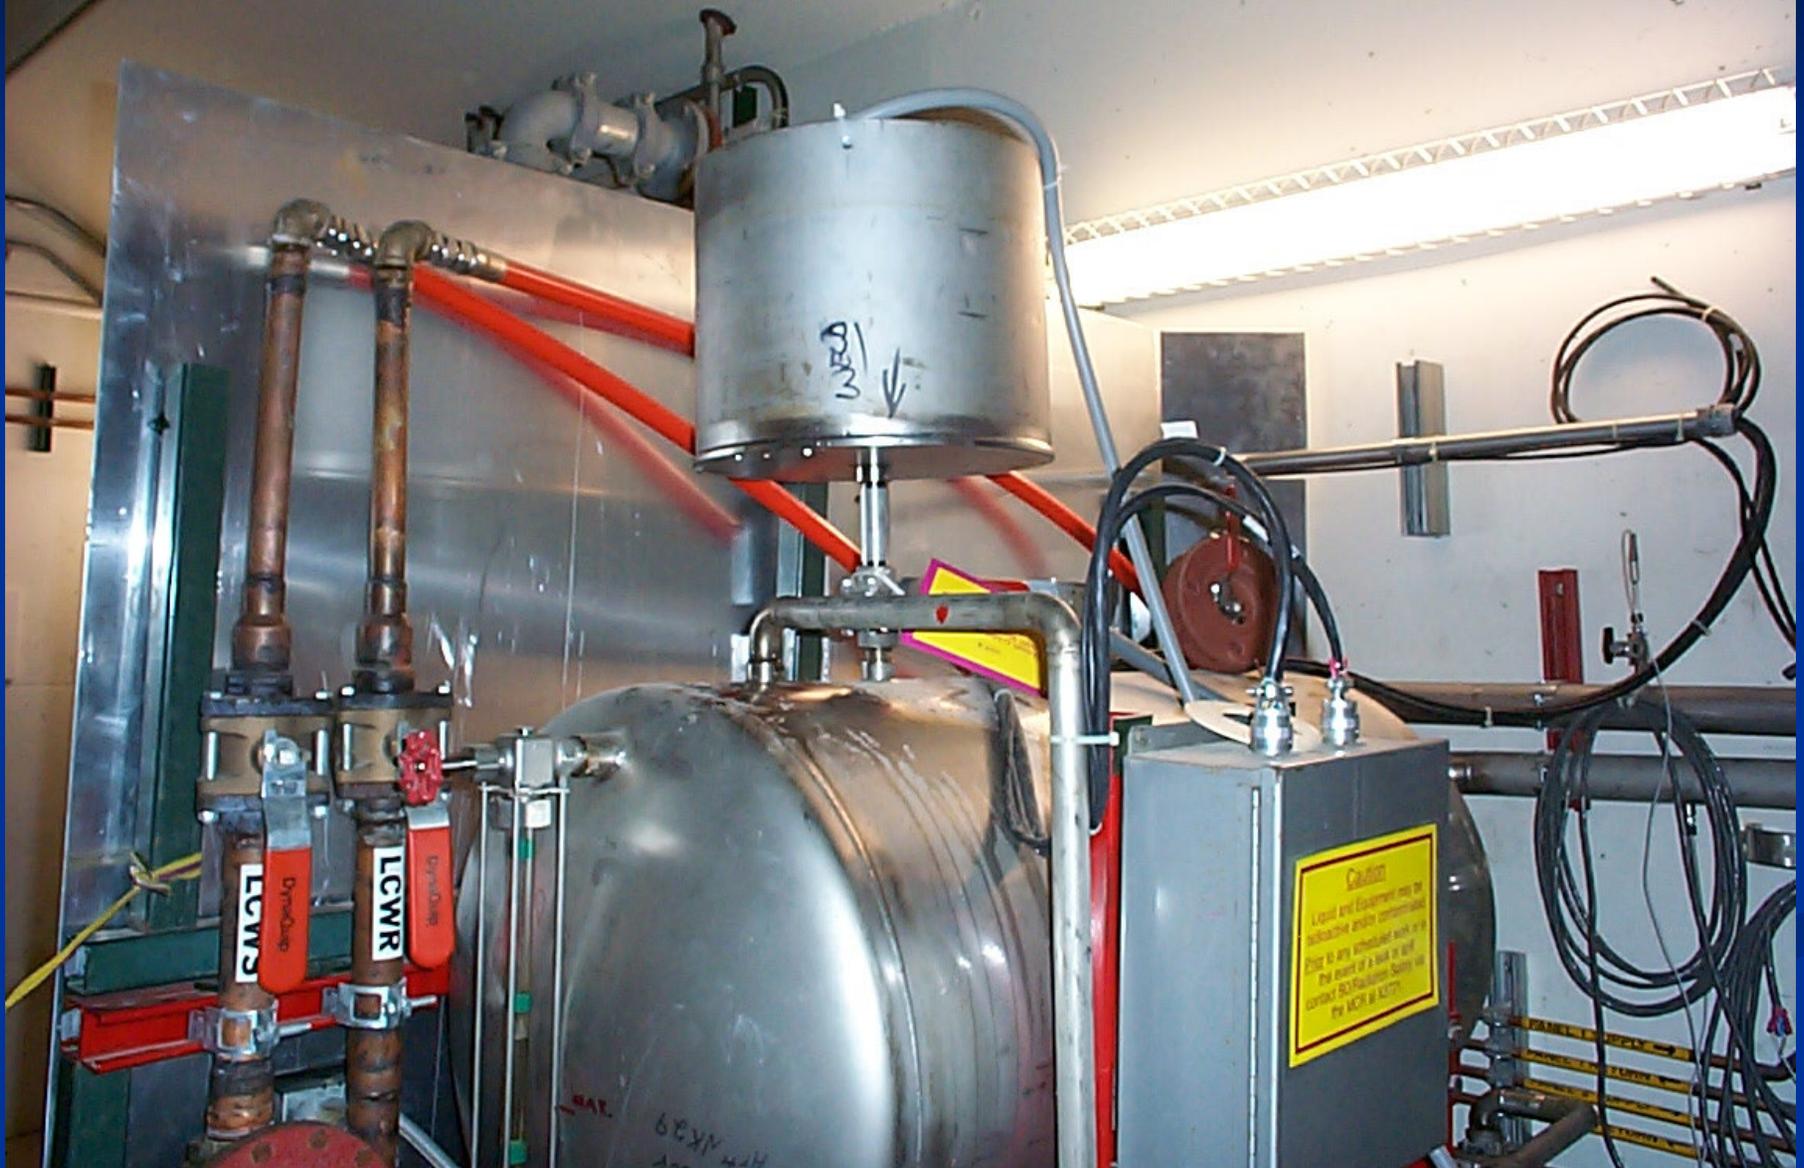
The calibrated 5 gallon bucket to add water to the surge tank of the RAW system

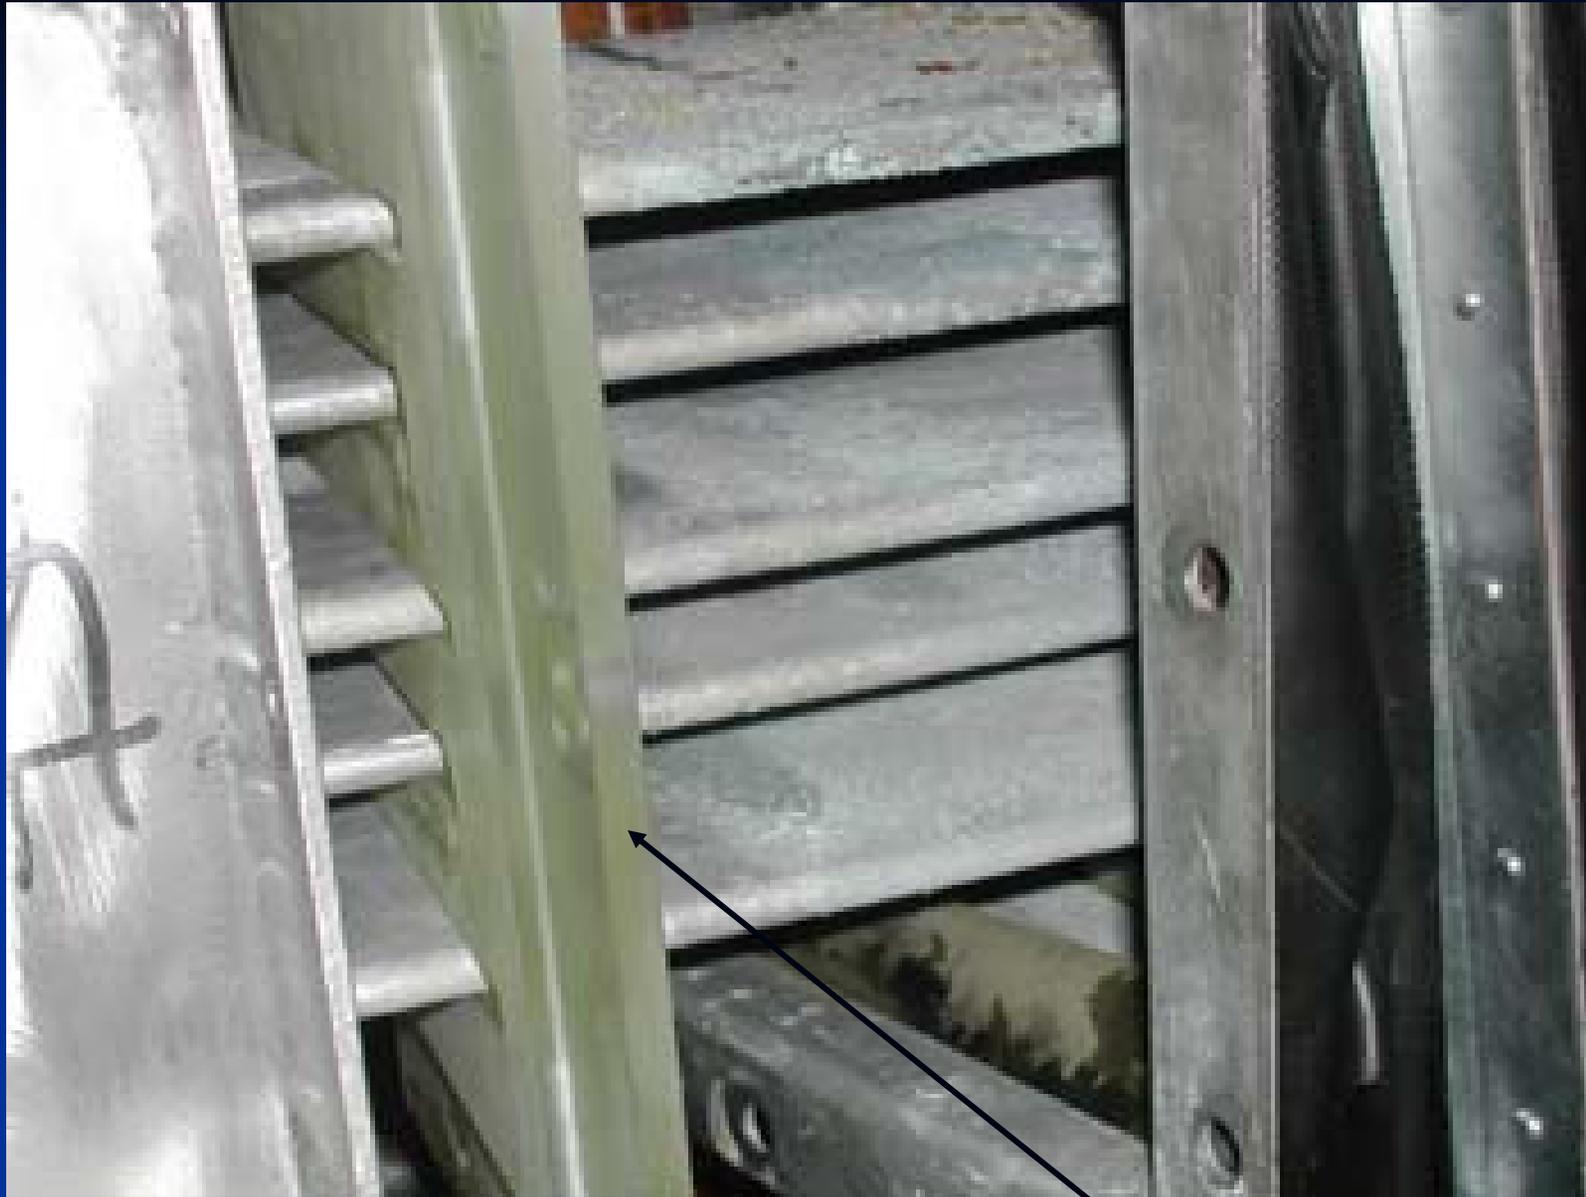
- The next few pictures show where we saw stripline corrosion—and where we didn't
- The corrosion ended right at the air barrier on the stripline
- The parts inside the horn box are covered with a white powder that is mostly aluminum oxide and makes the pictures look like those from sunken ships

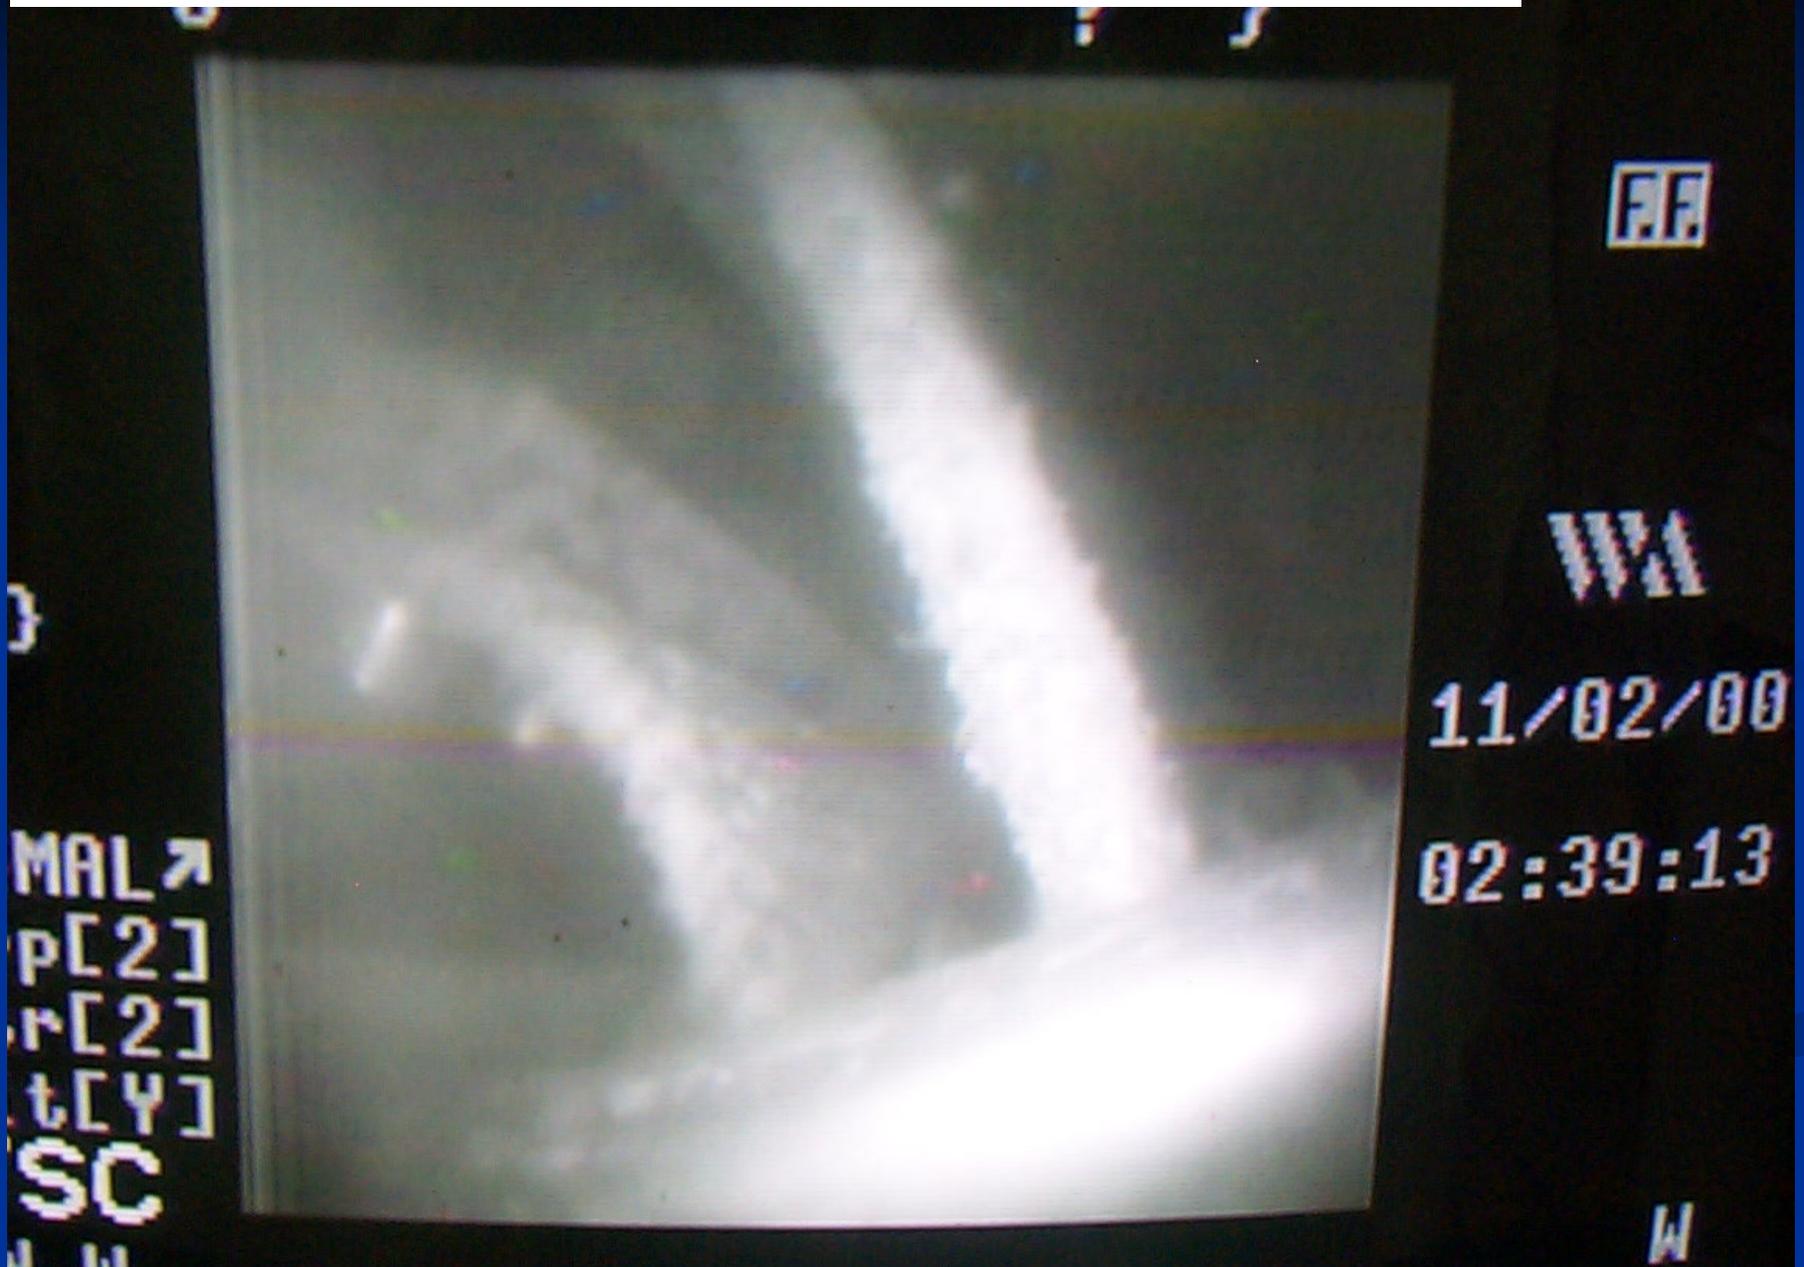
Borescope pictures of the connection between the stripline and horn

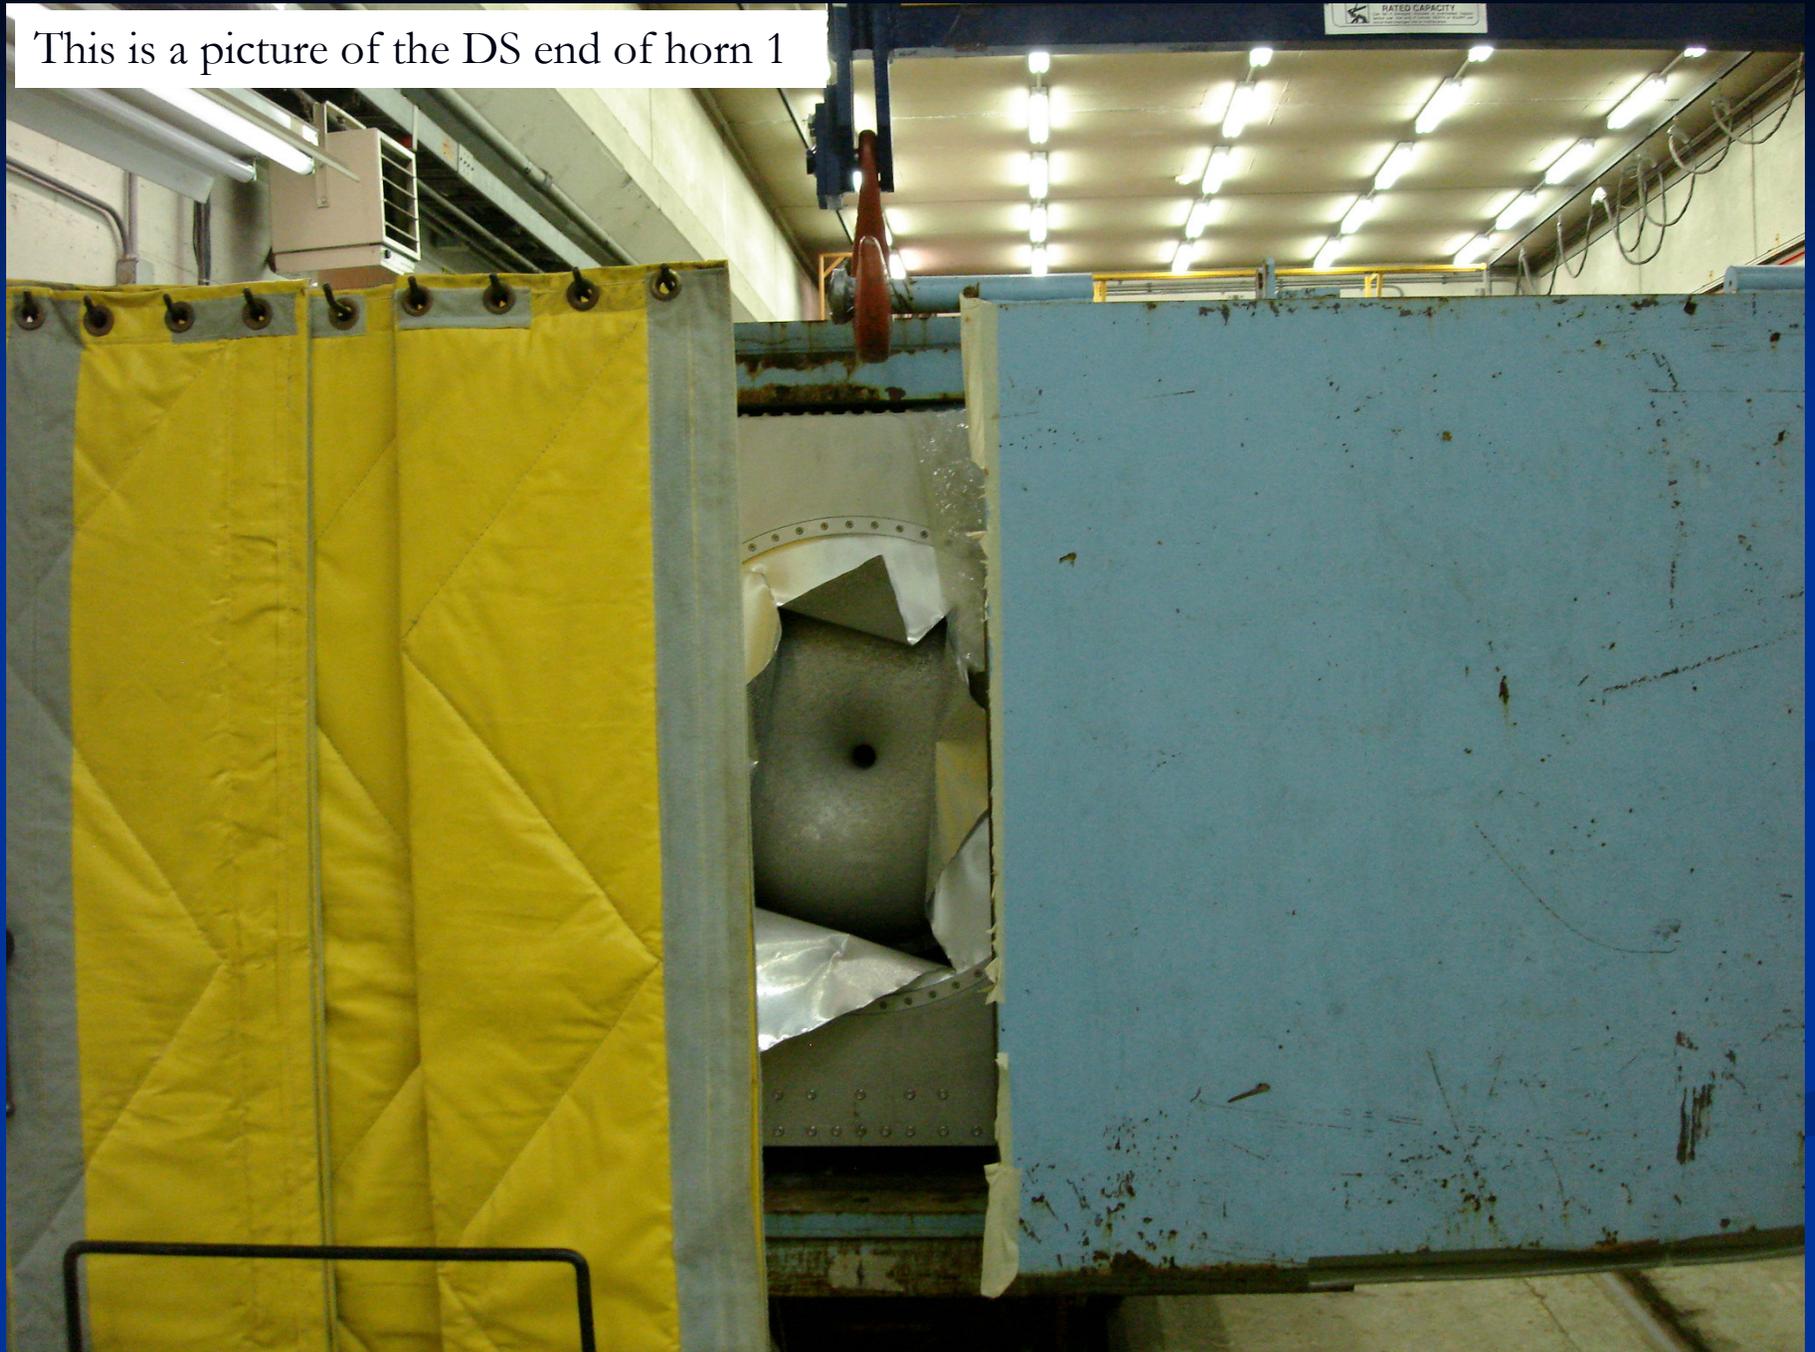
This is a picture of the DS end of horn 1

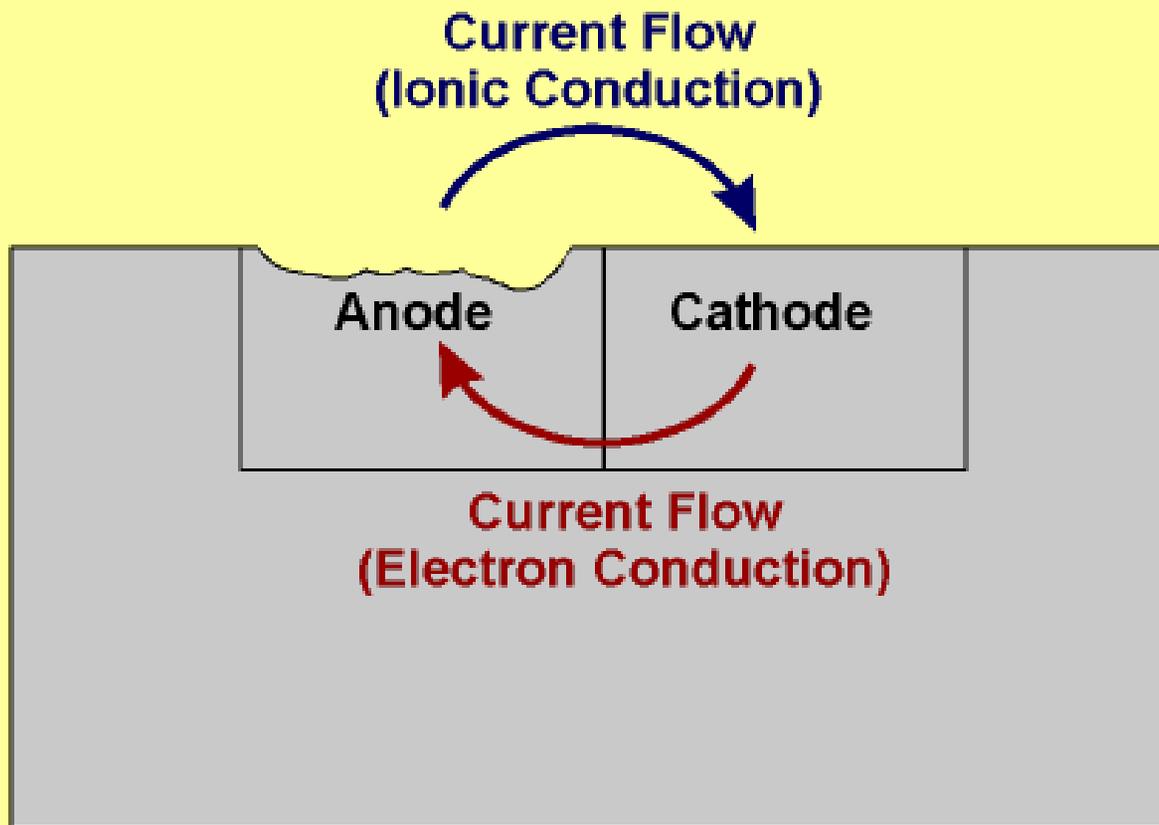
1. There must be two electrochemically dissimilar metals present
 - Stainless 304 and Aluminum are far apart in the galvanic corrosion series
2. There must be an electrically conductive path between the two metals
 - They are squeezed together in a seal
3. There must be a conductive path for the metal ions to move from the more anodic metal to the more cathodic metal
 - The RAW water

A simple corrosion cell

If any of the three necessary conditions are not met, galvanic corrosion cannot take place. The horn satisfies all three conditions and because of the water sealing requirement, it is hard to break one of the conditions
